# **Report on Texada “goop” used on Denman Island**

Nick Doe P.(Eng), Hon. Research Assoc. Earth Sciences, Malaspina U-C.

June 7, 2008

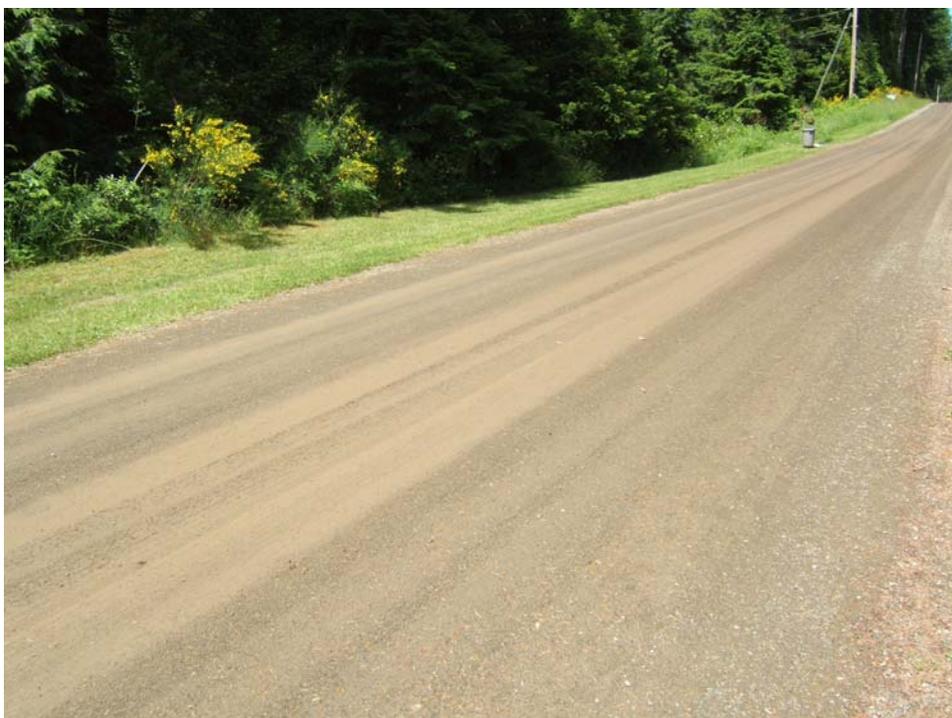
Many stretches of unpaved road on Denman were free of potholes (including dried-up ones) and were slime-free at the time of the visit. They were also not dusty. All roads were in, as good as, or better shape than Gabriola's.

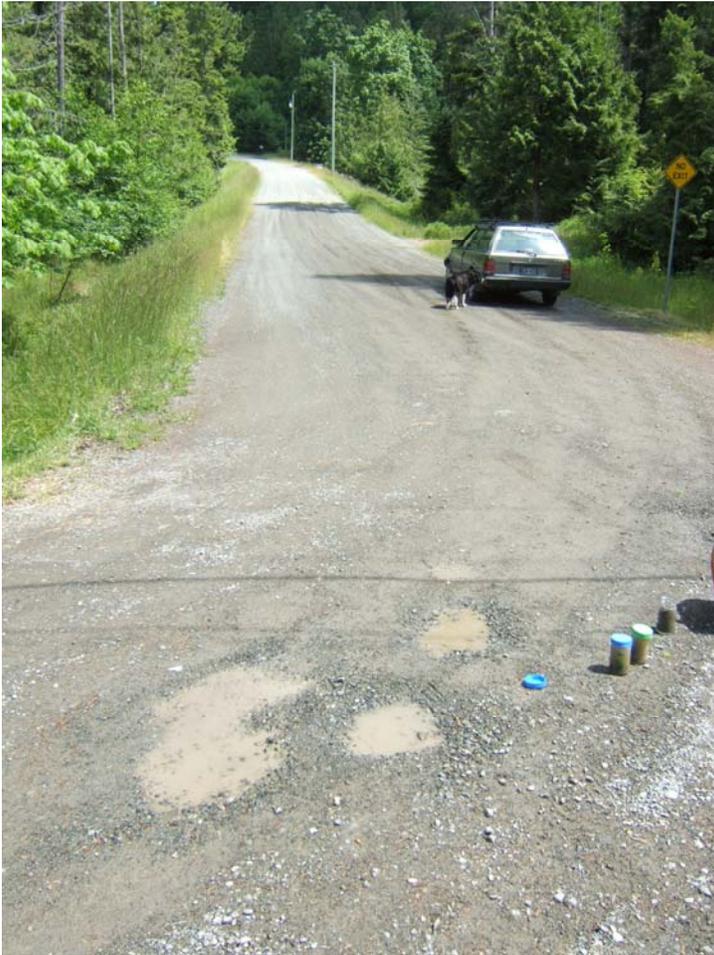
Where potholes existed, they were either at the bottom of inclines or near the junction with another road.

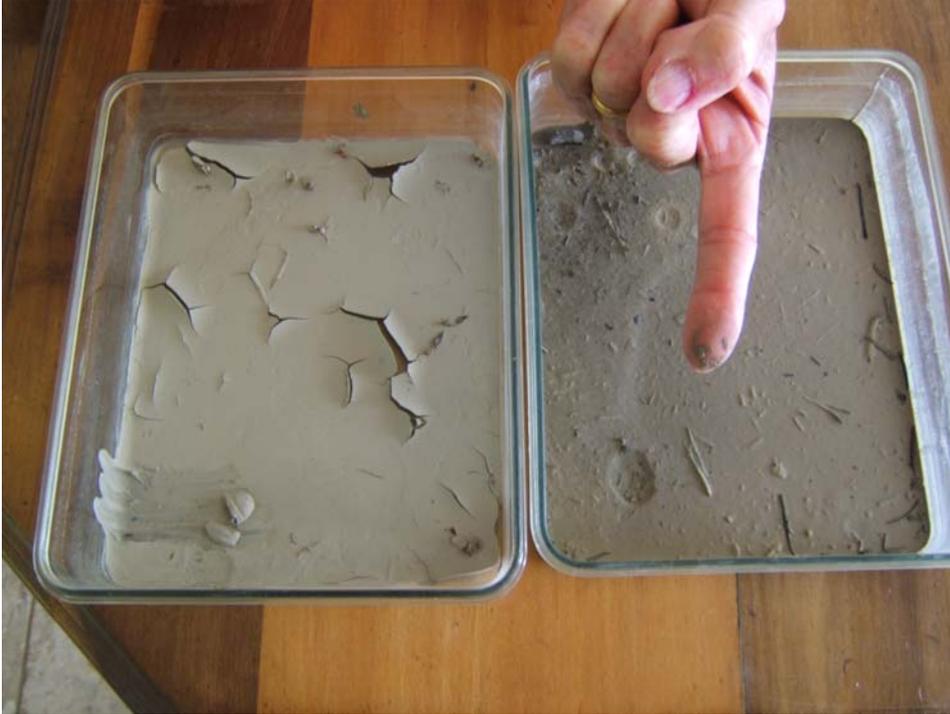
*Left:* clay from Denman Island goop. *Right:* clay from Gabriola Island goop.

The clay from Denman (*left*) dries out quickly and leaves tension gashes as a result of shrinkage. In contrast, the Gabriola clay (*right*) dries more slowly and is still sticky after a week of extra drying. The surface remains intact even after prolonged drying.

The difference lies in the chemistry of the two. Unlike Denman clay, the Gabriola clay contains calcium carbonate which acts as a cement. Super-saturated solutions of calcium carbonate in the interstices of the clay expand slightly when they crystalize. This crystallization pressure locks the grains together, lowers the permeability of the concreted clay, and creates compression stress on the surface. The Denman clay remains as dried and caked mud and although the clay is relatively impermeable, it is brittle, fairly readily reverts to mud when water is added, and tension gashes allow trapped water to escape.

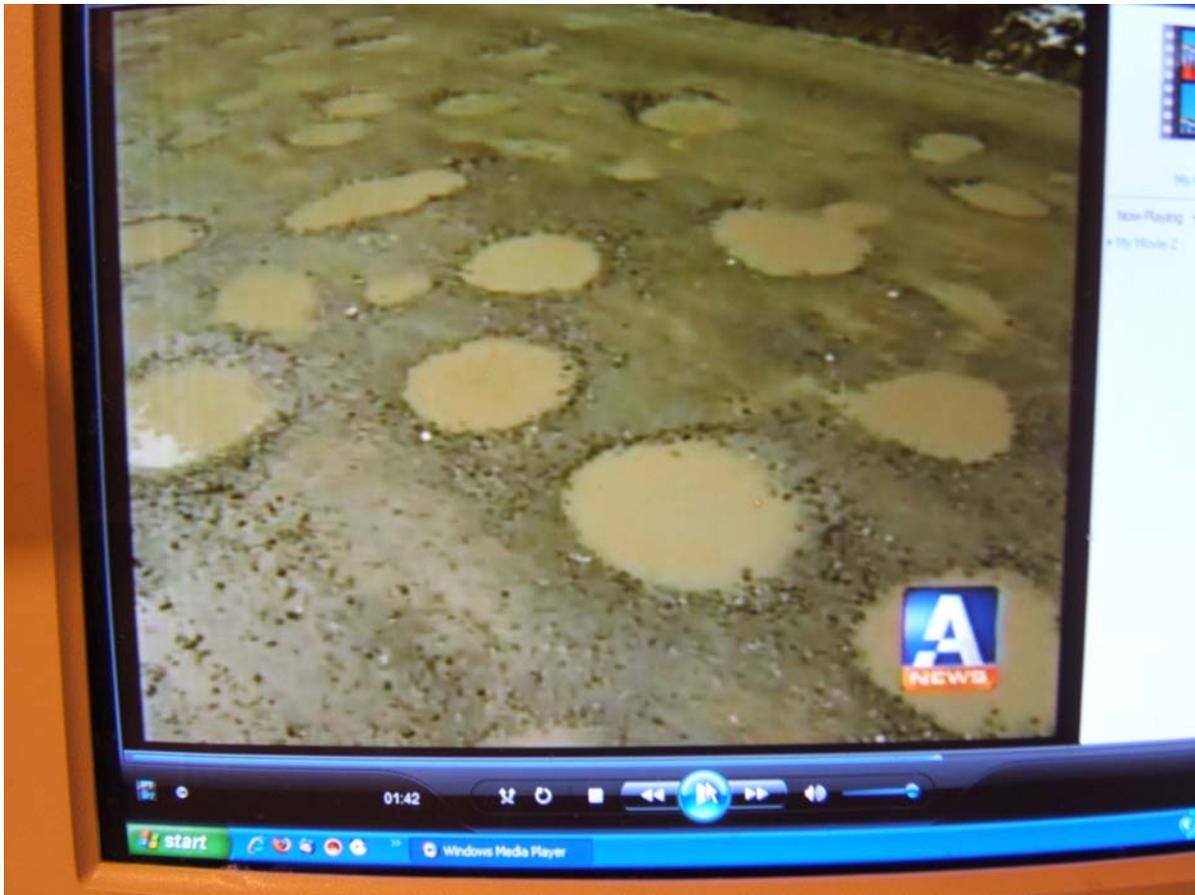
Potholes like these on Gabriola are forming a quasi-hexagonal patterns with spacing determined by the “zone of influence” of the individual holes.

The radius of the zones is probably a measure of how far away from the hole clay-laden water has to be before it fails to return to the hole after being splashed out by a vehicle. Note the coarser material accumulating around the perimeters of the holes. This is gradually being replaced by mud in the holes.

There must be a completely water-tight seal beneath the surface for this condition to persist. Evaporation is the only way the water can escape. The seal is likely being formed by carbonate loaded clay forming a sub-surface layer of claystone or concreted mudrock.

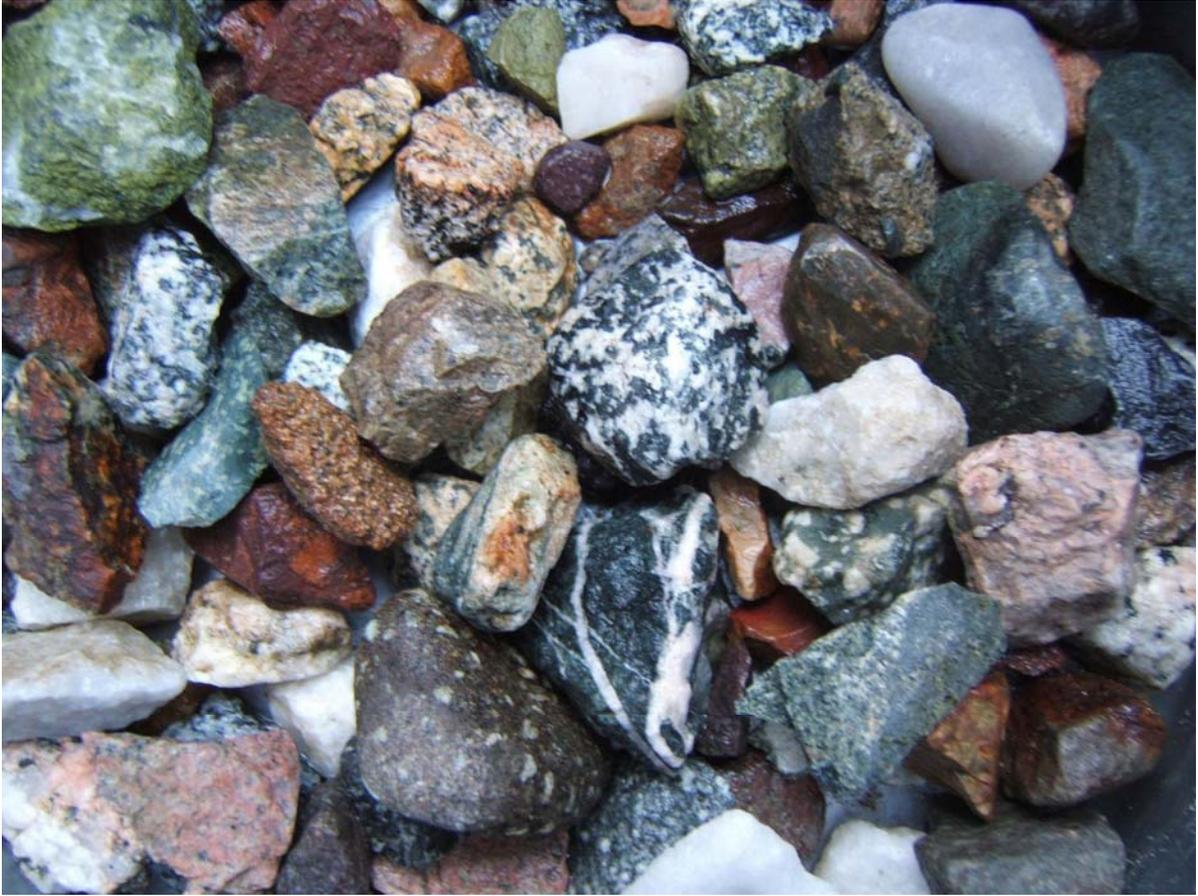
Selected grains of gravel in Texada aggregate from mixed sources. The abundance in the picture in no way represents the abundance in the bulk material; nevertheless, a good indication of how varied Texada geology is, and how samples can vary widely in their properties.
