Final report on Texada “goop” used on Gabriola Island.

Nick Doe P.Eng, Hon. Research Assoc. Earth Sciences, Malaspina U-C.

February 10, 2008; rev. February 11, 2008; rev. February 18, 2008

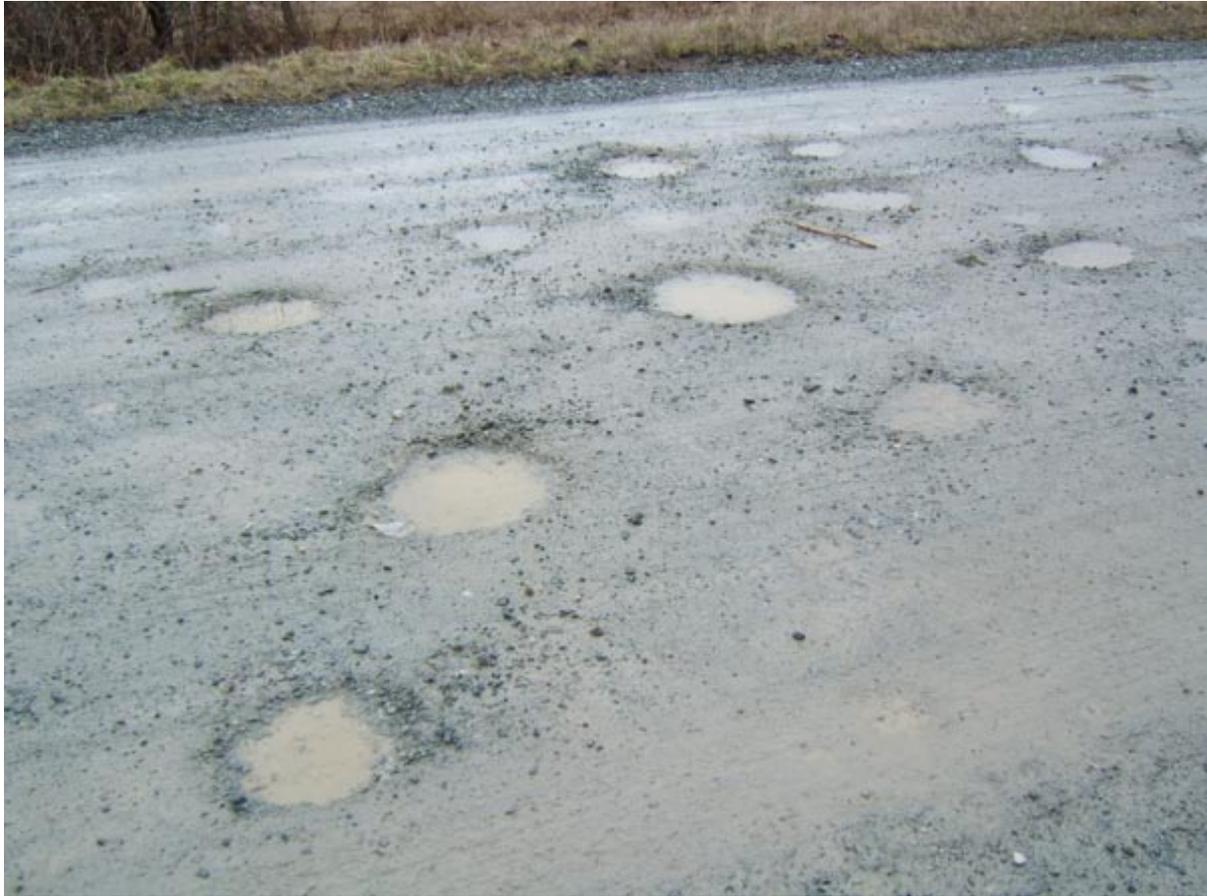
General view of the sampling site TEX-5 on Horseshoe Road, Gabriola
(no, not a NASA planetary flyby photograph).

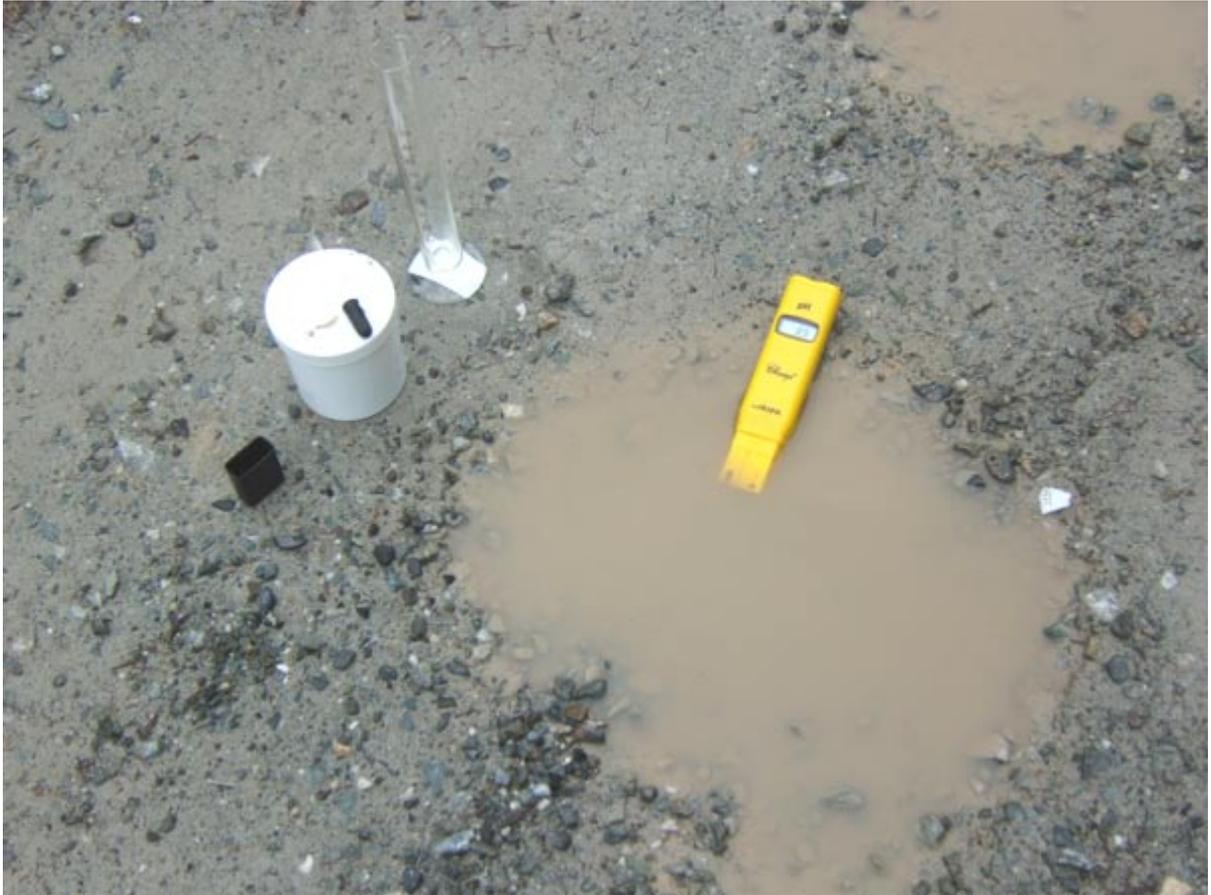
Taking sample TEX-5 on Horseshoe Road, Gabriola. The yellow instrument is the pH meter.

The brown colour indicates iron, but this is very common of course. The shales on Gabriola particularly contain a lot of it; very little iron is needed to provide colour; and iron is not a health hazard in groundwater. However, this particular sample did appear to be loaded with magnesium, probably from dust control treatment. The combination of calcite, magnesium chloride, and bentonite is a good candidate for being a major part of the “goop” problem.

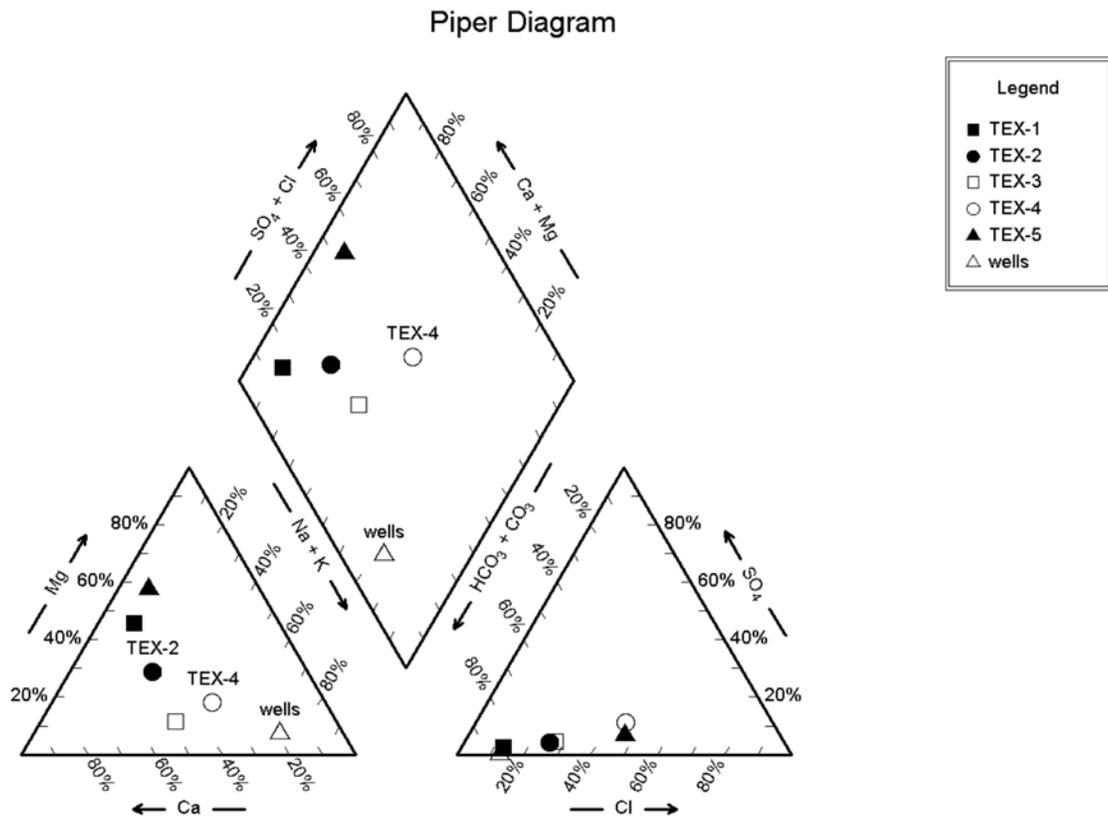
Piper diagram (all samples + well-water)

The pothole samples are TEX-1, -2, and -5 (filled symbols). TEX-3, -4, and “wells” (open symbols) are natural surface- or groundwater samples. All from Gabriola.

Note the unusually high content of magnesium in TEX-5 (the black triangle), implying application of MgCl₂.
