Survey of Winston Road allowance on Gabriola Island and its relationship to lower Mallett Creek

Nick Doe June 10, 2015

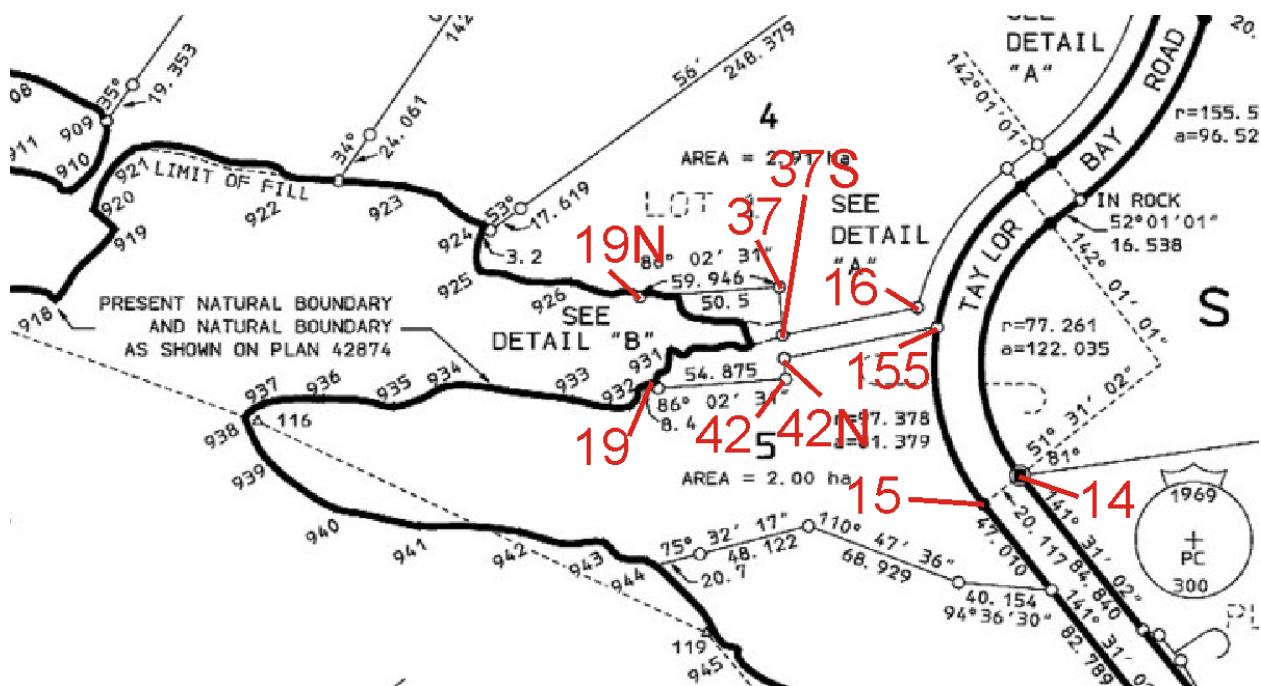
Extract of RDN map VIP86742. The 10 numbers in red are arbitrarily assigned iron pin (IP) numbers; they do not appear on the RDN map, in other documents, or on the IP locator stakes in the field.

Of the 10 pins, two could not be found (no metal detector); these were 155 (the last post of the split-rail fence along the road?) and 42N (stake had been discarded down the slope, and orange-tape flag was lying detached on the track). Pin 19N was not visited.

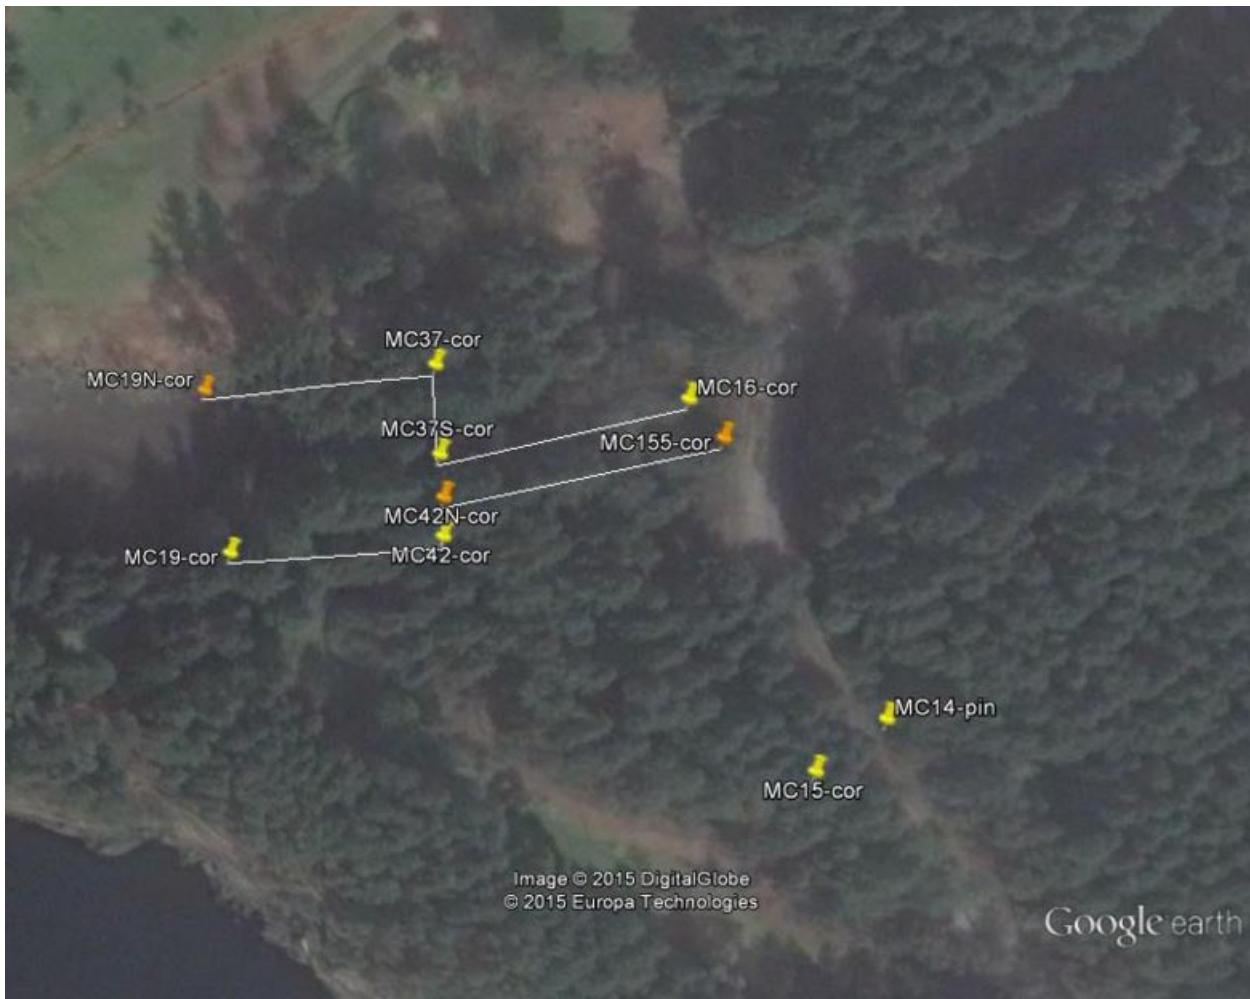
The positions of the array of ten pins on a Google Earth view.* Relative pin positions are as in the RDN map all referenced to pin 14 (MC14-pin) whose geographic position was found by GPS. The tree cover prevents the course of Mallett Creek being clear, but distance measurements and compass bearings on the culvert** and house*** near the sea confirmed that although this mapping may not be entirely accurate, errors are reasonably small and it conforms with what you see on the ground.

* scale is 20 metres between MC14-pin and MC15-cor.

** the culvert was observed 5 metres bearing 77° from MC16-cor. This puts it within the Taylor Bay Road allowance.

*** the house is, in this view, near the annotation "MC37-cor", as far horizontally to the left of the "M" as the "3" is to the right. It was observed 59 metres bearing 30° from MC19-cor.

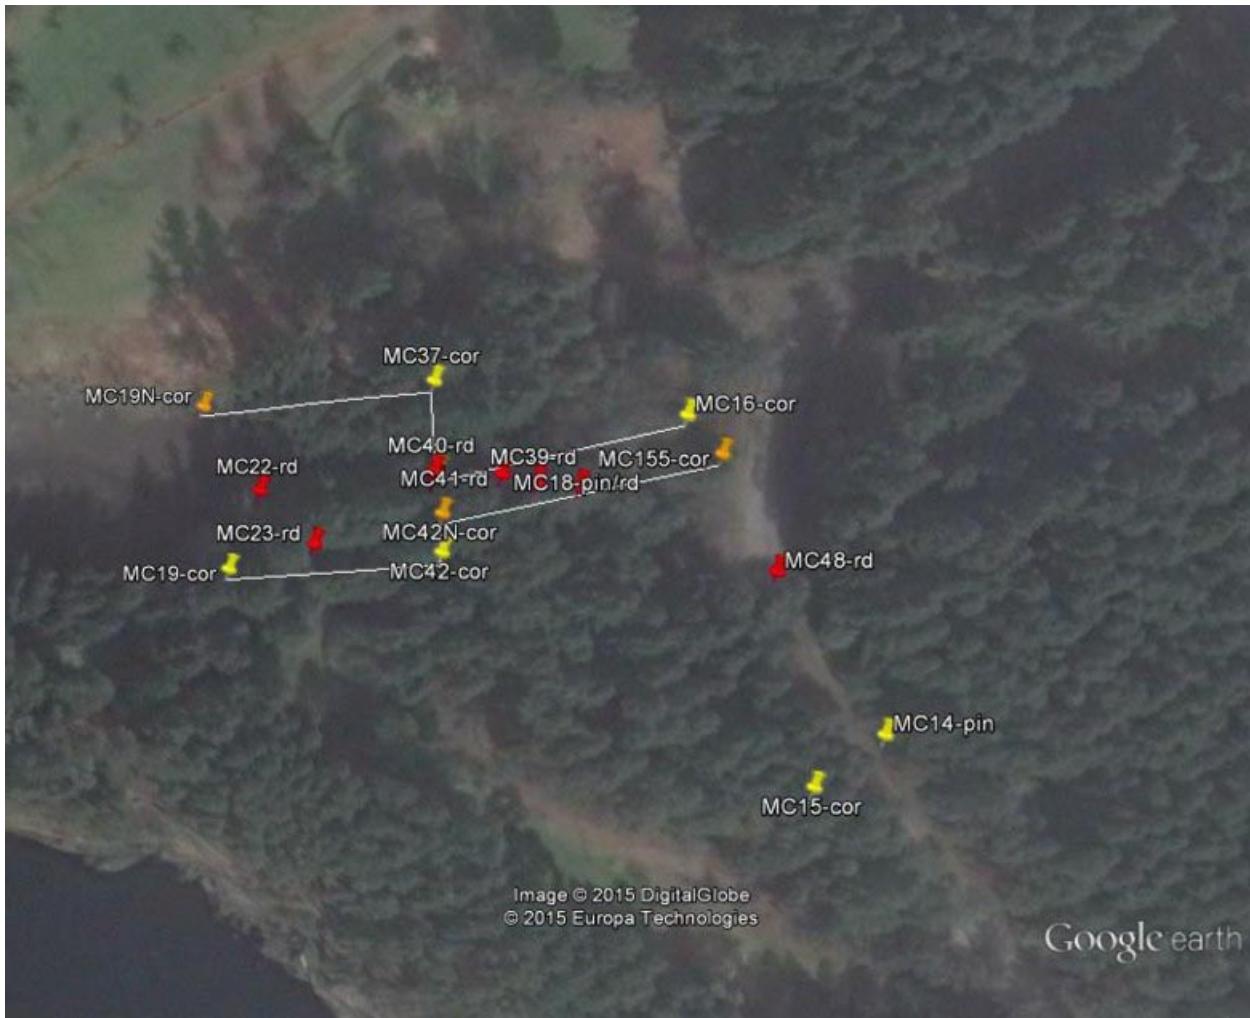
Point 48 (MC48-rd) in the view below indicates only roughly where it would be possible to provide vehicle access to the junction of Winston Road and Taylor Bay Road after leveling, ditch filling, and fence removal. There is however no demand for this and zero likelihood of this happening any time soon. For all intents and purposes, the trail is a wide footpath to the sea.

The same view as before but with observed GPS positions of the centre of the trail from Taylor Bay Road to the sea. All positions fall within the road allowance except for MC48-rd which is not a survey pin and only indicates roughly where the trail might meet Taylor Bay Road without a steep incline up the Mallett Creek/Taylor Bay Road embankment if it were ever constructed.

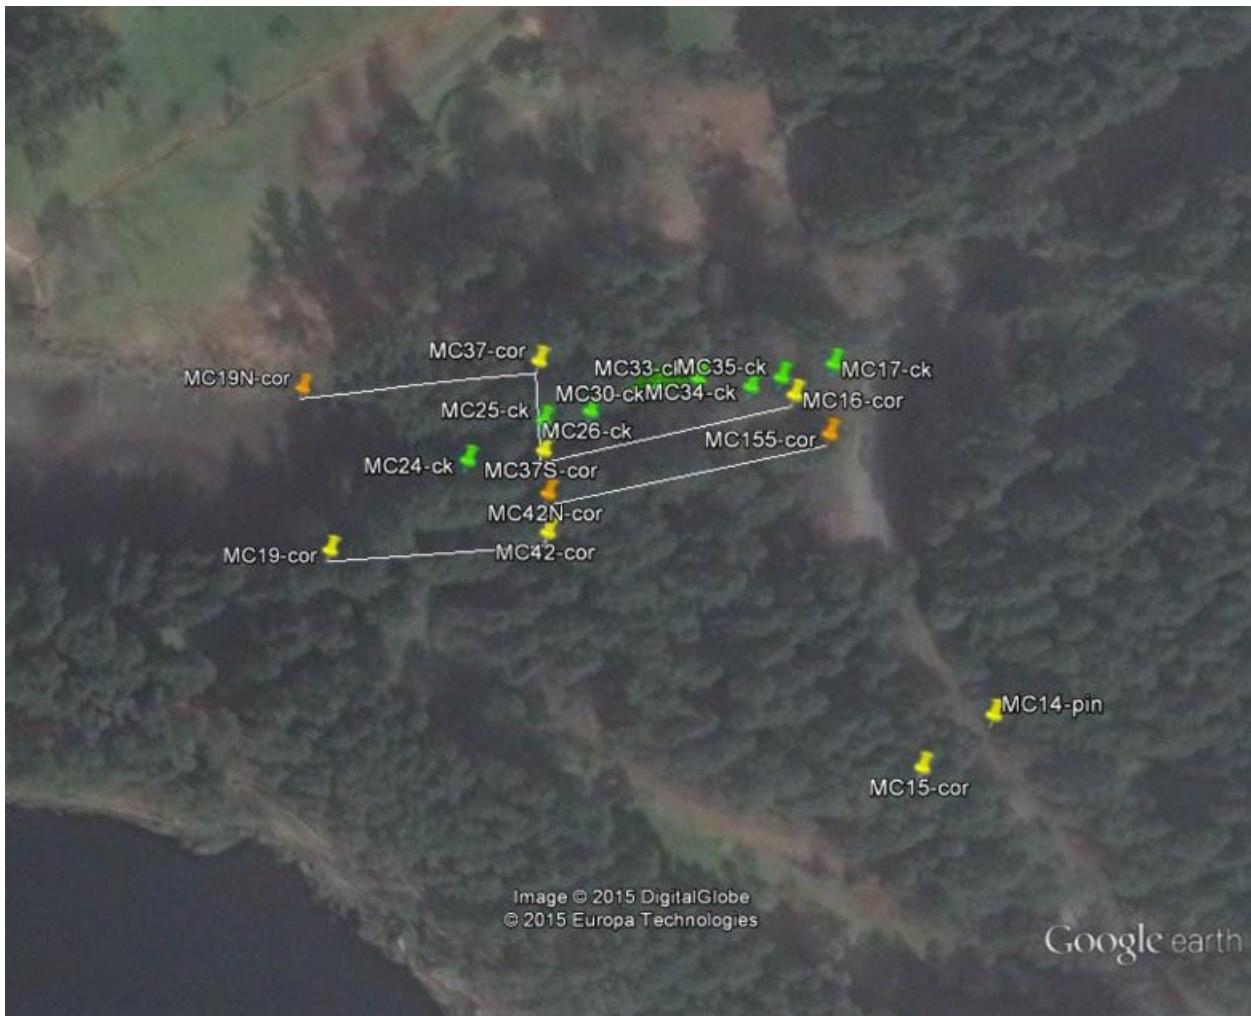
The same view as before but this time with the observed GPS positions of the thalweg of Mallett Creek. Pin 37S (MC37S-cor) is on the southern edge of the creek bed and would be submerged when the creek is in full flood.

The Winston Road allowance appears not to include Mallett Creek except when it is almost at the sea, although the distance between the north edge of the trail and the creek in the ravine below is at one place only about ten metres.
