Addendum to report on Texada “goop” used on Gabriola

Magnesium/calcium silicate scaling

Nick Doe P.Eng, Hon. Research Assoc. Earth Sciences, Malaspina U-C.

February 20, 2008

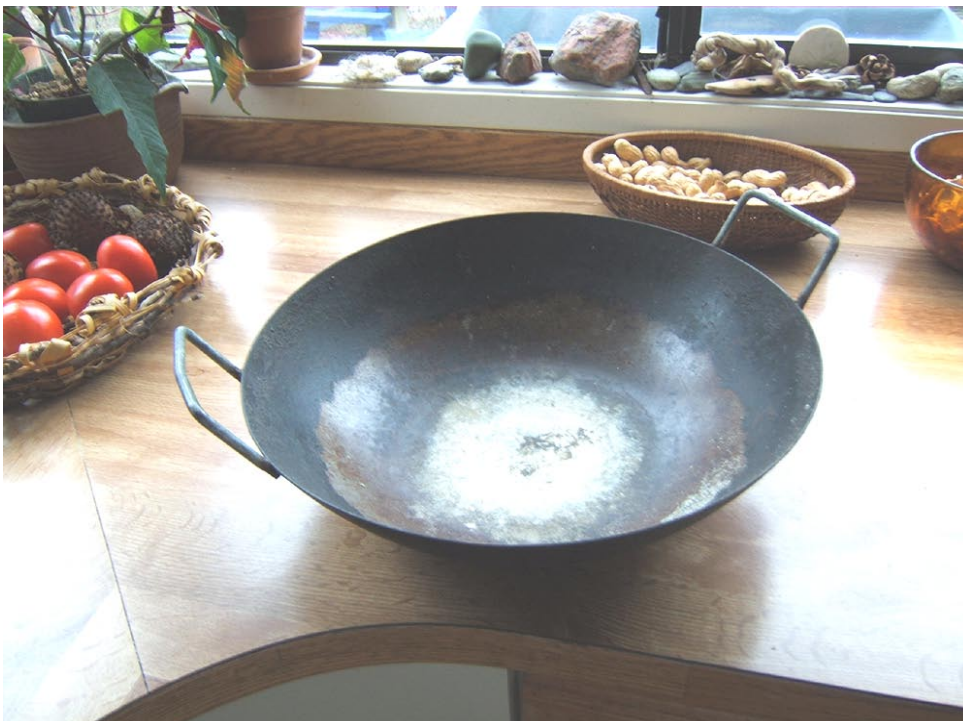
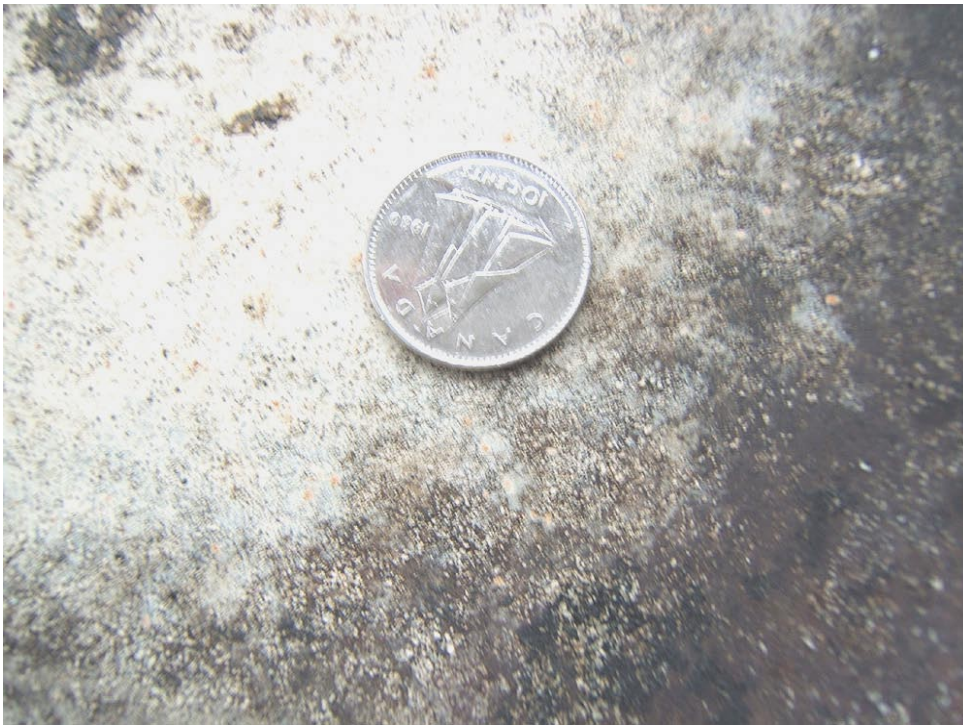
To confirm that I was not going off on a technological tangent, I did the simple experiment of slowly removing the water from a goop sample in a warm wok on the kitchen stove. After the water had gone, I discarded all the powdery material, and was left with a wok with a thin white film on the bottom adhering to the metal surface. This could not be removed by vigorous washing or rubbing with fingers, but it could be by using a regular plastic dish scrubber.

I showed my wok to the owner of the Gabriola Automotive Company (Tim Nicklom), who services many “gooped” vehicles on the Island. He assured me that the stuff in my wok had all the physical qualities and appearance of the material he was seeing on the inside of brake drums. It is therefore a reasonable supposition, I think, that part of the “corrosion” problem is silica scaling. Jeremy Baker has observed the formation of a silica gel in goop-laden water, likely initiated by a drop in pH. Smectite clays are, as are all clays, rich in silica.
