Coats Marsh Weir Removal: Environmental Impacts and Mitigation Measures for Weir Pool Area

Regional District of Nanaimo
1490 Springhill Road
Parksville, BC V9P 2T2

EDI Environmental Dynamics Inc.
208A – 2520 Bowen Road
Nanaimo, BC V9T 3L3

23N0435
Version: 1.0
October 2024

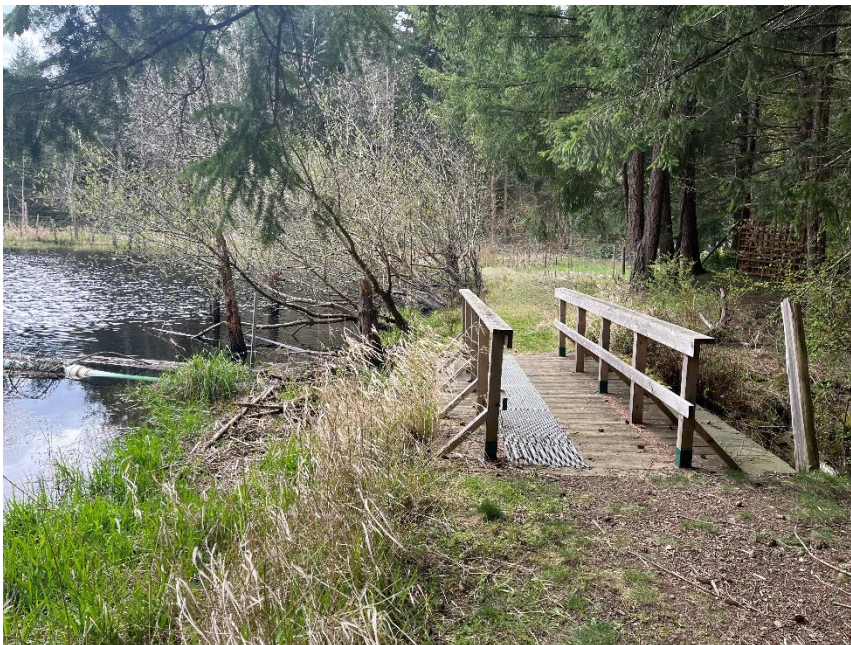
Photo 3-1 Wood bridge over Coats Creek and adjacent to cement weir

Coats Marsh weir is a concrete outlet weir that is approximately 3.3 m high (downstream side), 6 m wide and 0.6 m thick with a wooden bridge built to cross the water outlet. The weir, bridge and berm are located on Coats Marsh Creek at the west end of Coats Marsh on Gabriola Island (Photo 3-1). The water storage capacity at the weir crest elevation for the full marsh area is approximately 38,950 cubic meters (NHC 2023b). The weir pool area is estimated to have a capacity of between 5% to 7% of the full marsh area, with the weir pool volume ranging between 2,000 and 2,700 cubic meters.

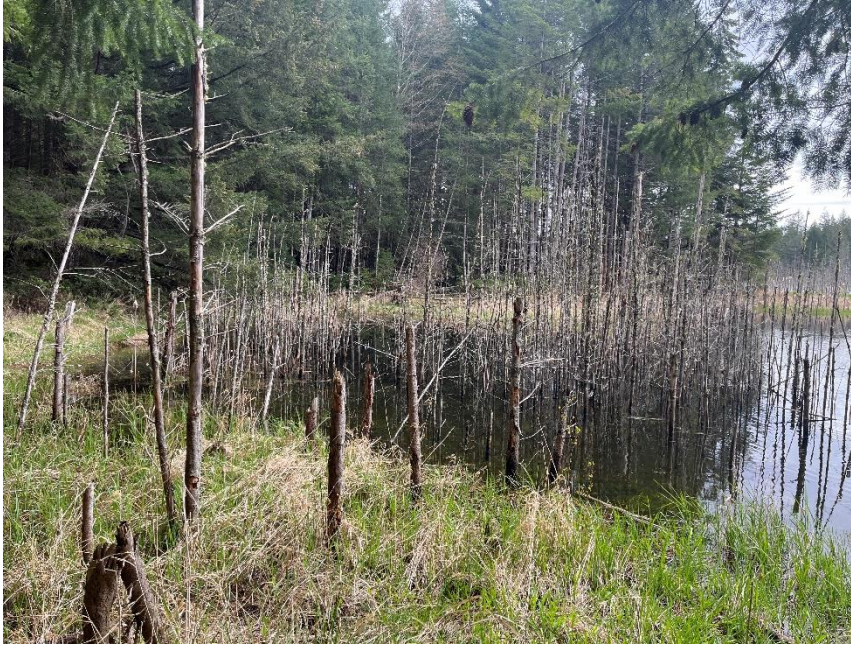
Photo 3-2 Marsh area that is currently dominated by invasive reed canarygrass.

Vegetation in Coats Marsh varies with hydrological conditions. Shallow water areas are dominated by water smartweed (*Persicaria amphibia*), yellow pond lily (*Nuphar variegata*), and other aquatic species. Transition zones feature emergent plants like sedges (*Carex* sp.), pondweed (*Potamogeton* sp.), and marsh horsetail (*Equisetum palustre*) (see Photo 3-2). Margins of the wetland, influenced by periodic flooding, support shrubby vegetation like pink spirea (*Spirea douglasii*) but are extensively dominated by invasive reed canarygrass (*Phalaris arundinacea*) (Photo 3-2). Reed canarygrass thrives in habitats characterized by fluctuating water levels, and frequently out-competes native wetland vegetation.

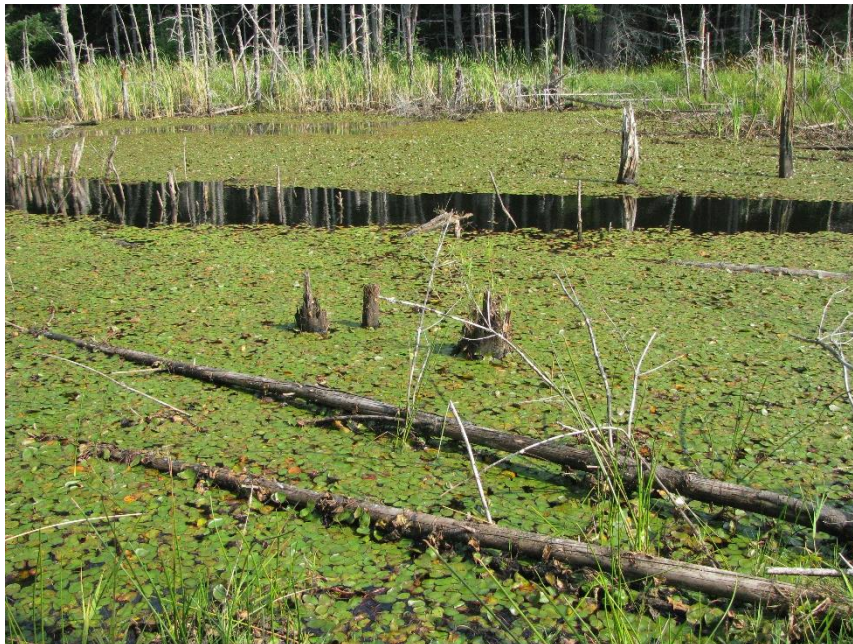
Photo 3-3 Weir pool area with shallow open water transitioning into marsh (looking north).

The upper extent of the wetted perimeter of the marsh areas contains numerous standing dead trees. This indicates that ecological conditions were previously drier and have changed in recent history, associated with increased water retention in the marsh. Beaver activity at the weir over the past decade is likely responsible for the increased water retention. Although the edges of the wetland may previously have been more characteristic of a swamp ecosystem, with higher water levels in recent years, these areas have now transitioned into wetter marsh conditions with small standing dead trees.

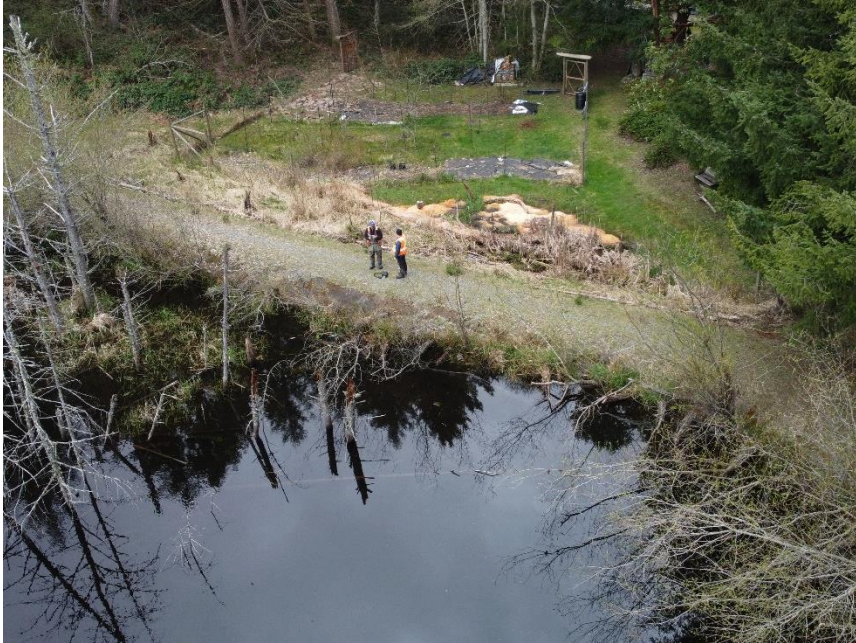
Photo 3-4 Existing earthen berm south of weir

The existing earthen berm extending from the south side of the weir may be modified as part of decommissioning, which would represent a possible change in vegetative cover (Photo 3-4). Restoration prescriptions will be further refined upon confirmation of the final decommissioning design.

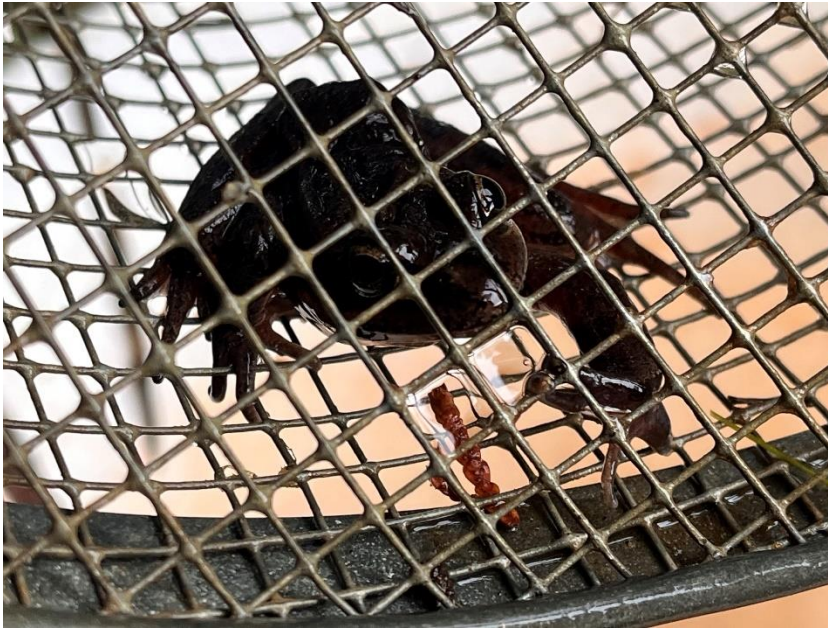
Photo 3-6 Incidental catch of northern red-legged frog in minnow trap

During EDI's assessment of the weir pool area on April 4, 2024, no red-legged frog egg masses were observed, while many of the underwater vegetation stalks were occupied by Pacific chorus frog egg masses (Photo 3-5). Incidental catch during the fish sampling program indicated the presence of adult northern red-legged frogs, Pacific chorus frogs, and rough-skinned newt in the weir pool area (Photo 3-6). Of these species, the northern red-legged frog is identified as a priority species, being protected as a species of special concern under the federal Species at Risk Act and as a Blue-listed species provincially. As such, consideration must be given to the potential impacts of the project to northern red-legged frog populations at the weir pool.

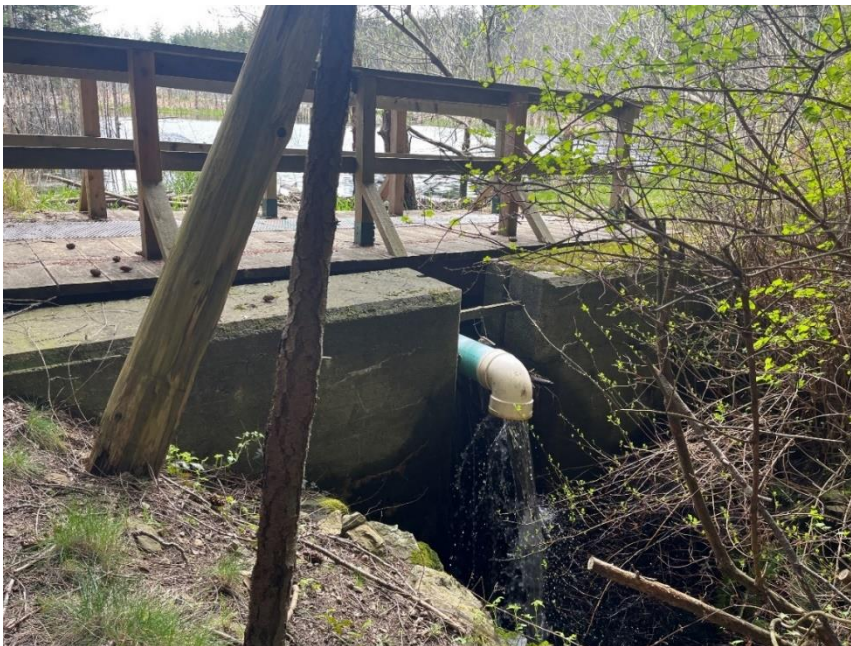
Photo 3-7 View of the syphon at the downstream side of the concrete weir on April 4, 2024.

Fish habitat between the concrete weir and the beaver dam is limited, particularly for salmonid species. The weir pool offers no fish spawning gravels, having a substrate dominated by organics. The weir pool presents some opportunities for rearing and overwintering, but the pond remains inaccessible to fish due to various barriers to fish passage, including the syphon installed at the concrete weir (Photo 3-7) and the height of the concrete weir during low to average water elevation. At high water elevation the concrete weir is overtopped due to limited flow through the existing pipe outlet of 0.2 m diameter (Photo 3-8), although the lack of a plunge pool at the bottom of the weir prevents fish from being able to jump over the weir.

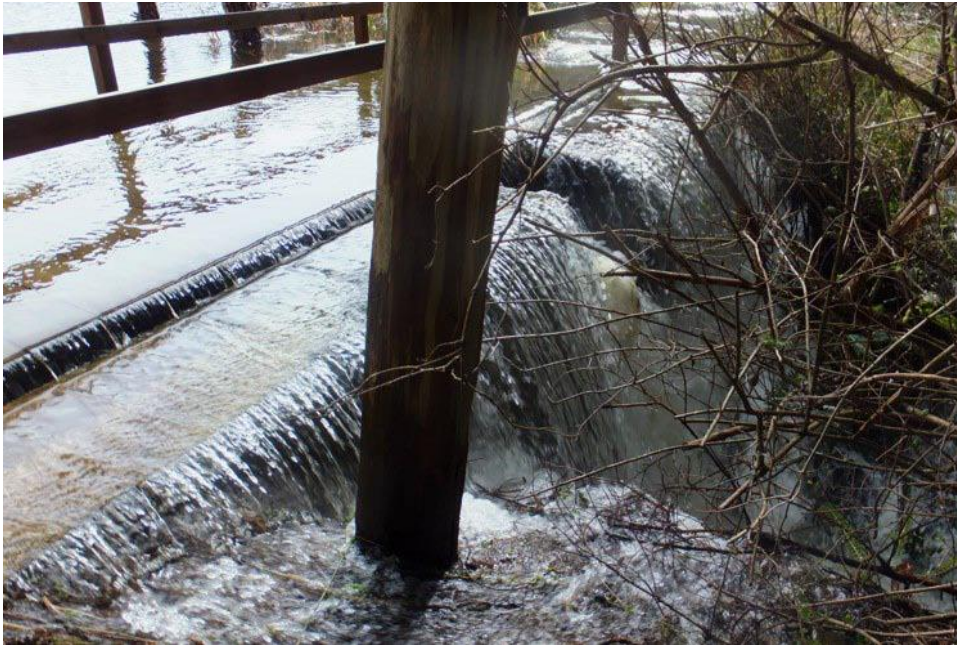
Photo 3-8 View of the syphon at the downstream side of the concrete weir on March 10, 2016 (photo by Gabriola Streamkeepers 2017).
