Gabriola Streamkeepers—Water levels and quality

Observations at Coats Marsh, Gabriola Island

Field observations—2025 (Oct.—Dec.)

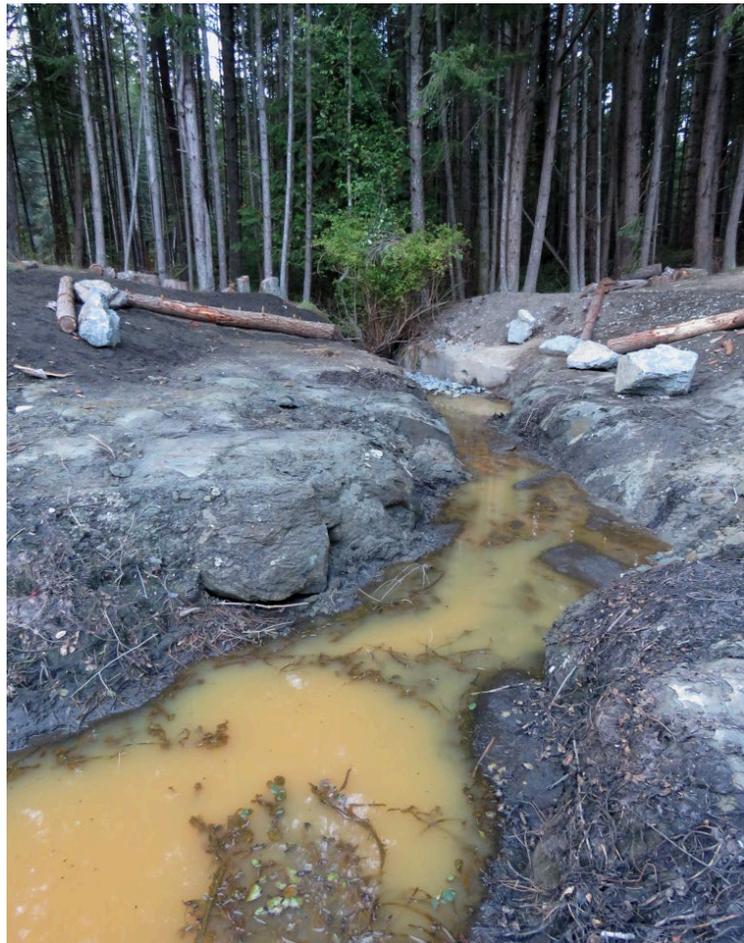
Not a lot going on at the weir site. Looks like the project is winding down? If so, couldn't they just have taken the flashboards out?

Although there are iron-oxidizing bacteria that can turn water with an iron component orange, I've convinced myself that what we're seeing in the runoff from the beaver dam to the weir site is inorganic (*ferrihydrate*).

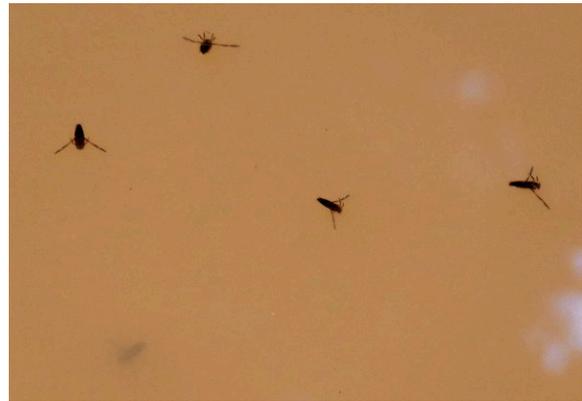
The bed of the stream is a very fine, grey mud with a silky texture; fine silt at the most, and more likely finer, probably too fine to be the result of glacial erosion.

The gelatinous substance in the mud, I guess to be a colourless silica-gel the ultimate weathering product of feldspars, mainly *plagioclase* in this case. The "fibrous" nature of the orange-stuff is not, as I supposed earlier, the result of a coating of decayed vegetation. There was no sign of this being so. Instead the filaments easily broke up completely on being lightly touched, leaving a cloud of small particles of a fairly equal size. These were tiny but not so tiny that they couldn't be seen, which perhaps rules against them being seeded by bacteria or other microorganisms.

Pretty harmless I would guess. It will wash out in the winter. At the moment the water has attracted the attention of water boatmen.

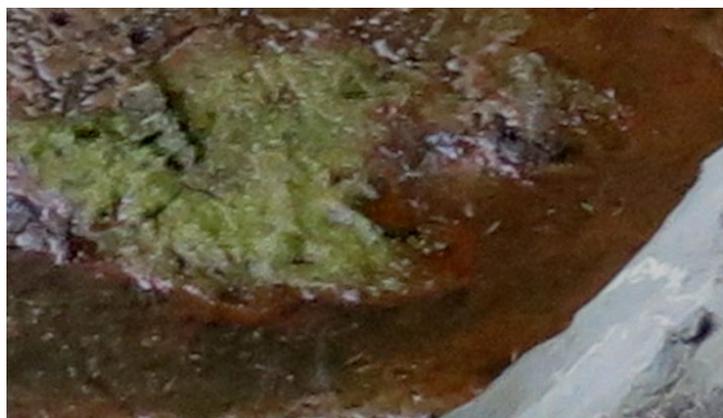
BUT, if you disagree with my interpretation you may like this picture. Algae or lichen? And why else would the boatmen be interested? They specialize in eating plant detritus.

Well, one retort is that *ferrihydrate* is the least insoluble of the iron[III] oxyhydroxides and so may just be acting here as a fertilizer for the photosynthesizing green stuff.¹

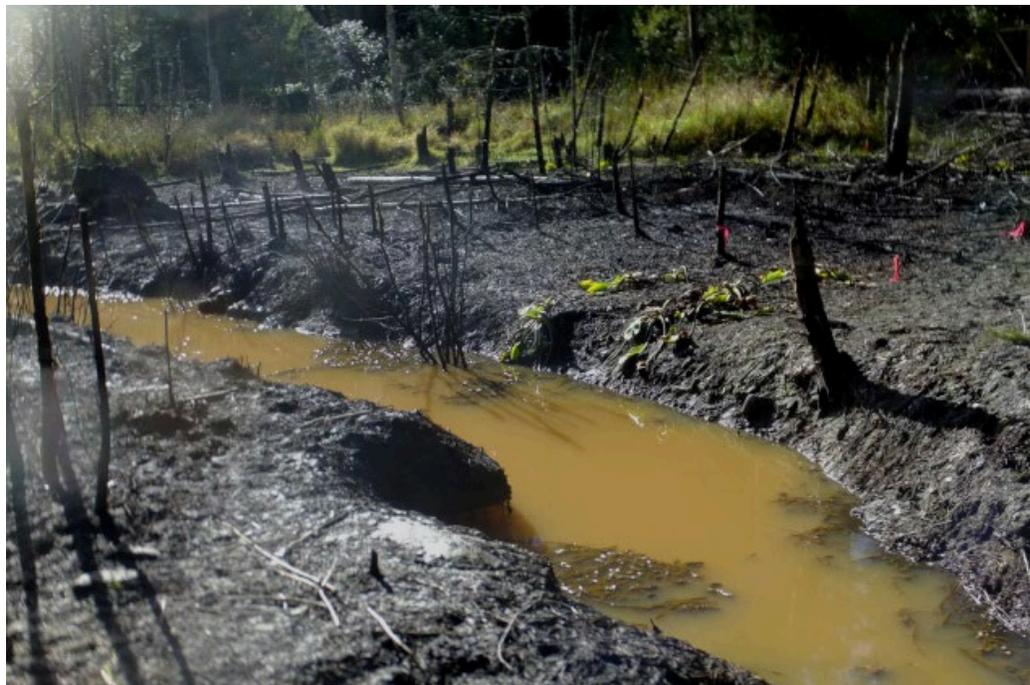
Work seems to have stopped at the weir demolition site. Surveyors have adorned the weirpool bed with red flags, and I guess the backfilling of the berm on Lot 5 has been completed. No prospect of a sluice gate which is what we really needed, if we needed anything.

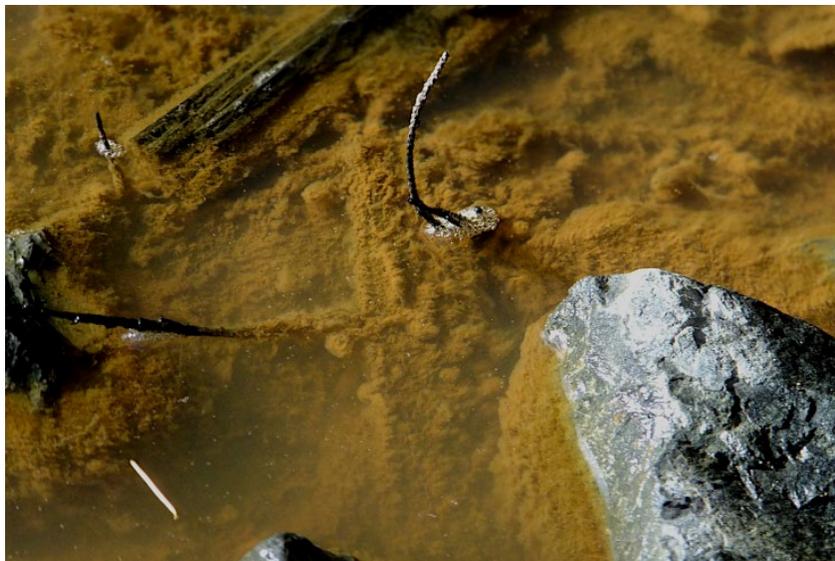
Recent rain has clarified the water of what I suppose we now have to call Coats Marsh Creek (below the beaver dam but above where the weir used to be). The *ferrihydrate* coats everything, even rock.

Microscope examination revealed nothing other than the smallness of the orange particles, too small for their structure to be seen.

They coat small grains of what I take to be *quartz* and perhaps fragments of *muscovite*. The nanoparticles are not magnetic.

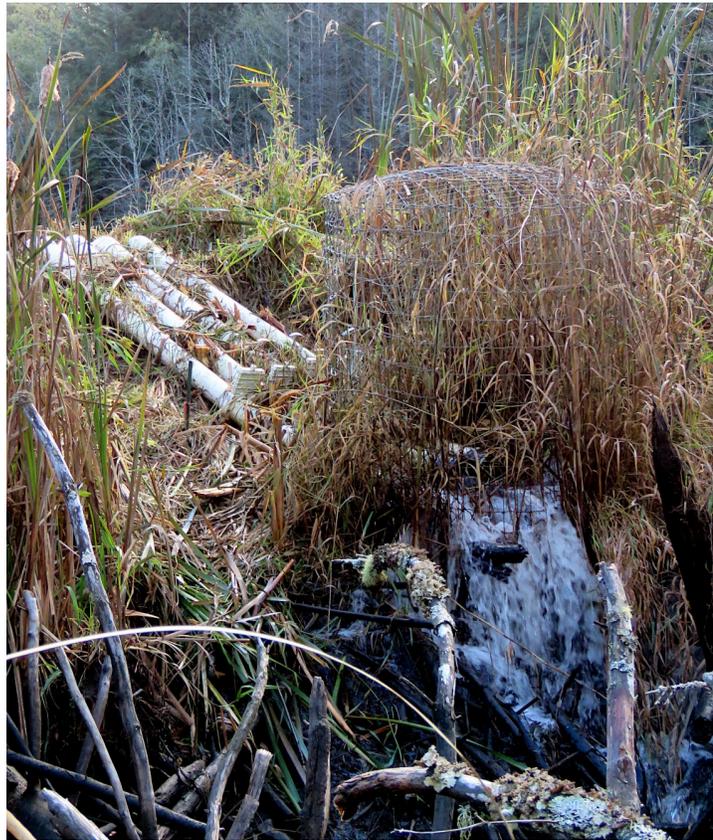
Lake level sharply down, after more than an inch of rain overnight. RDN have their syphons running again with the usual depressing-to-see, negative impact on the ecology of the marsh.

There seems to be no point in doing this when experience has shown that water level is quickly restored in a day or two of winter rain; it disturbs the arrival and settling-in period of the winter-resident ducks (no sign of them today); it disturbs migratory ducks using the wetland as a stop-over (no sign of them today either); East Path Creek and associated springs, which recharge the wetland in winter, remain dry and look like they're going to remain so for quite some time; the beaver dam already has adequate natural and beaver-built spillways; and expert opinion is that the dam is never going to fail catastrophically. The RDN has a bizarre way of managing a "nature" reserve. Sadly behind-the-times, stubbornly conforming to the traditional non-indigenous-peoples' notion that the over-riding purpose of parks and waterbodies-in-general is to meet the real and imagined needs of people. Their ill-advised water management practices are, for me, akin to bureaucratic vandalism.

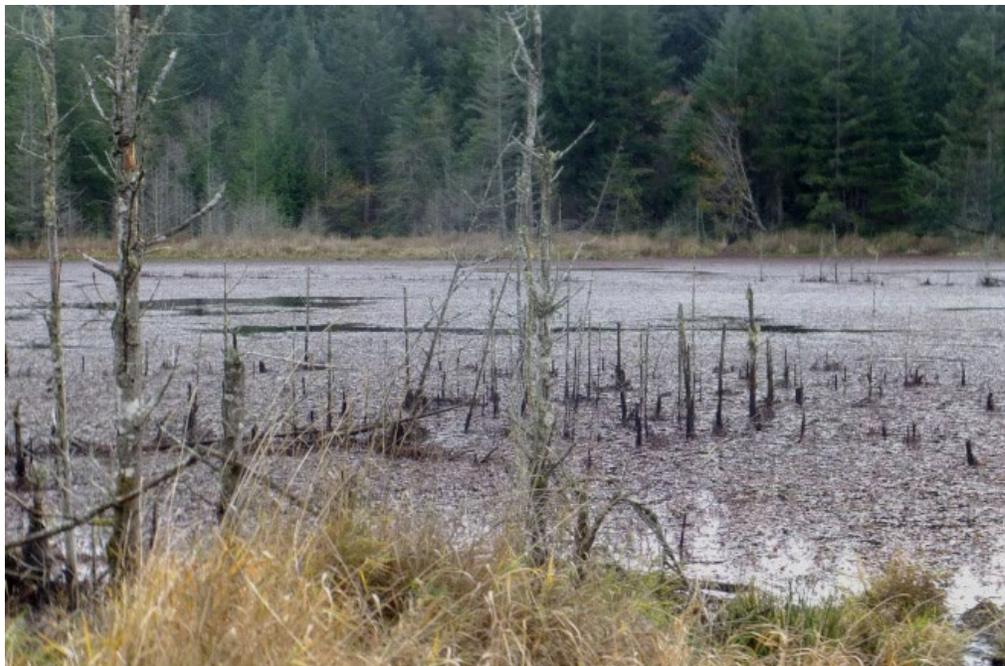
Light rain, on and off. The RDN continuing to drain the wetland with their syphons. The open-water on the lake is shrinking as the water shallows. Diving duck species, which includes many of the marsh's common winter residents, need open-water to take-off. No ducks now seen at the western end, divers or dabblers, only a small group of buffleheads at the eastern end.

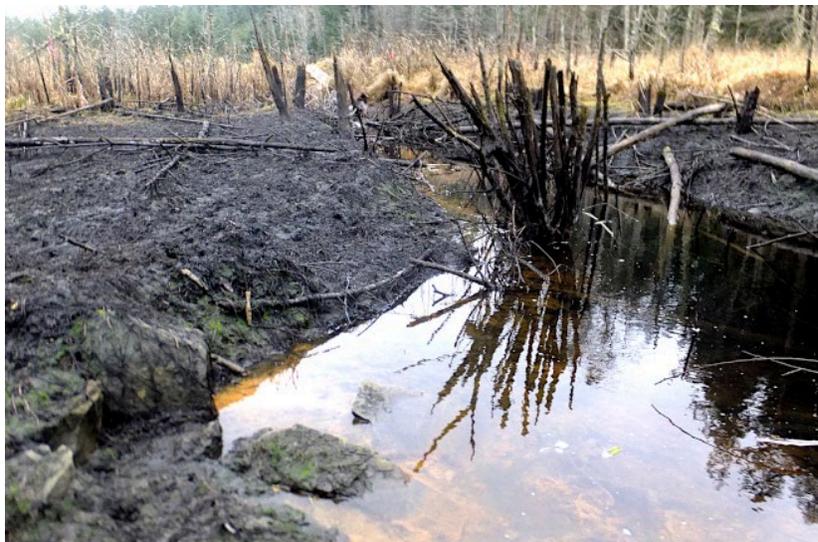
Not yet enough rise in the water level to cause any major spillage over the beaver dam so it remains calm at the weirpool.
