Gabriola Streamkeepers—Water levels and quality

Observations at Coats Marsh, Gabriola Island

Field observations—2026 (Jan.—)

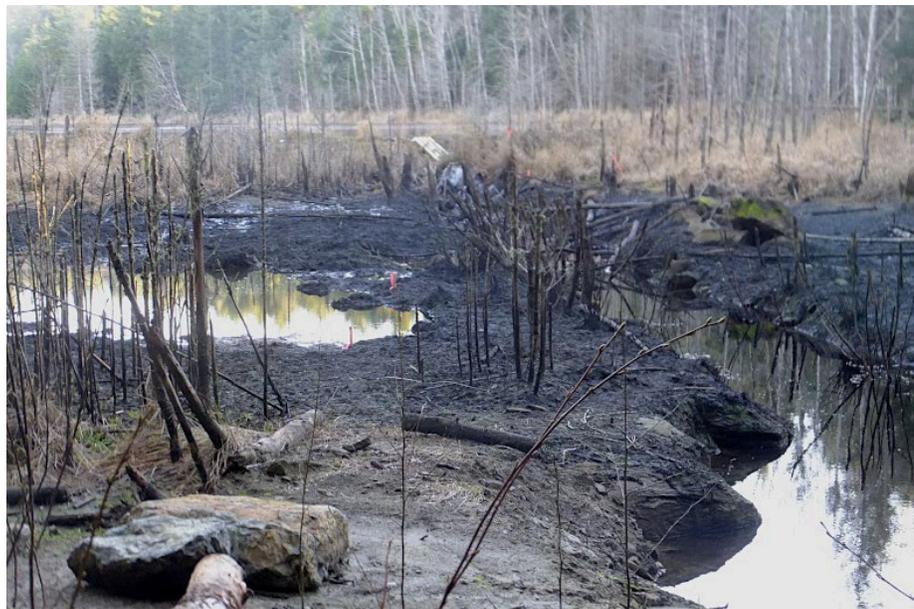
Photo previous page.
With the high water level on the up-side of the beaver dam, flow over the natural spillways beginning to supplement the flow of the syphons. The large puddle in the drained weirpool linking up with Weirpool Creek with at the moment just a little more than a trickle flowing through it.

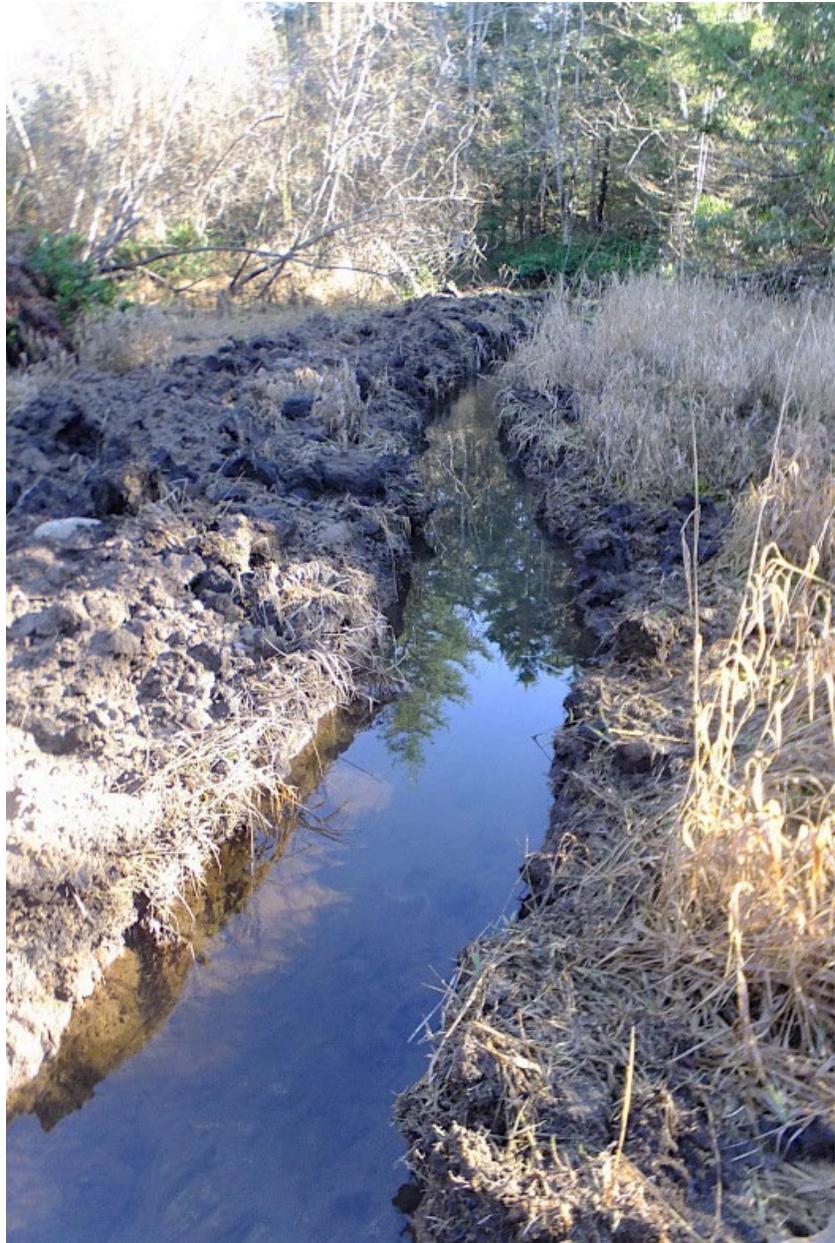
Both East Path Creek (EPC) and the NE Arm spillway running at about 50% capacity at East Path, which is rather light given the amount of rain.

The upper of the two Appleyard Ponds full (it was empty Nov.3 last year, photo), but the down-stream one empty. As mentioned last year (Nov.23) there has been heavy machine work going on in the apple yard property including rock breaking.

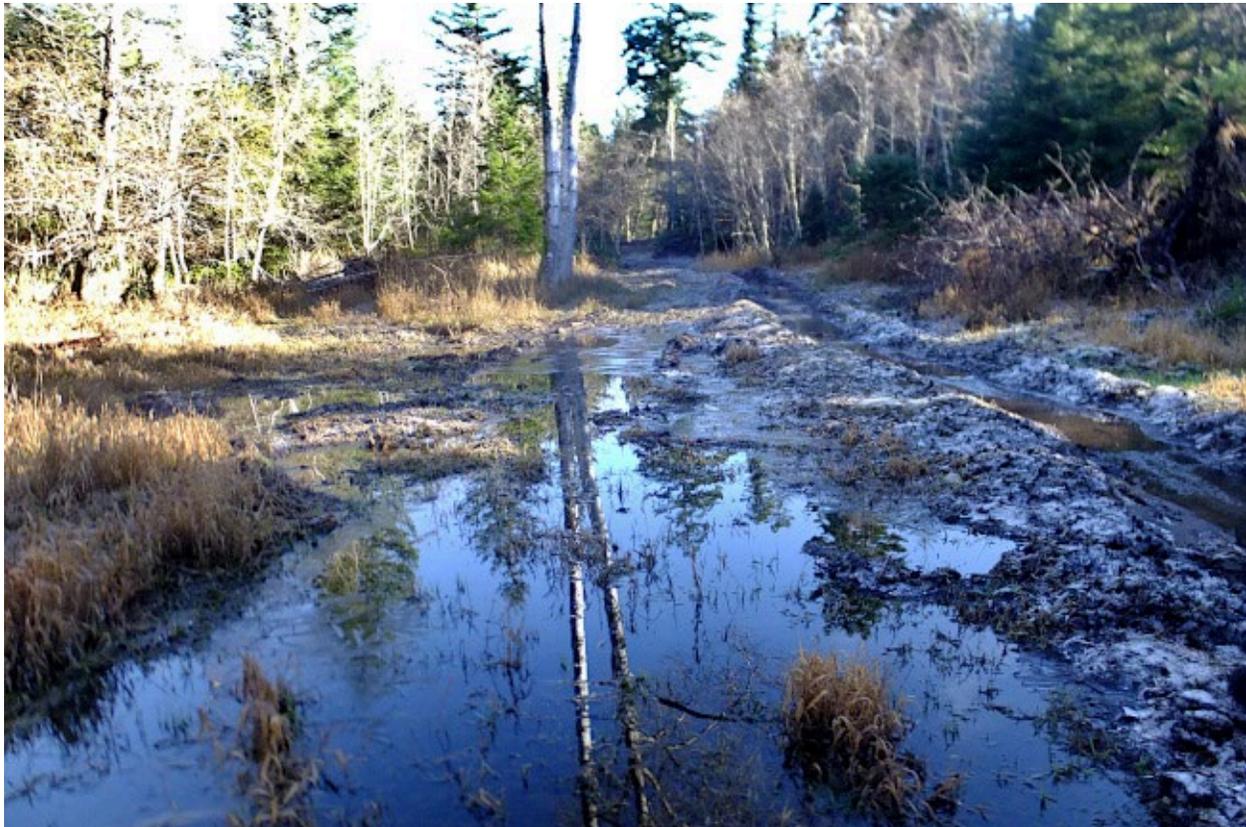
The pictures here and *previous page* show the ditch that has been dug down in places to bedrock where EPC runs through the SE Arm wetland. It is effectively draining the wetland and likely causing a significant change in its ecology.

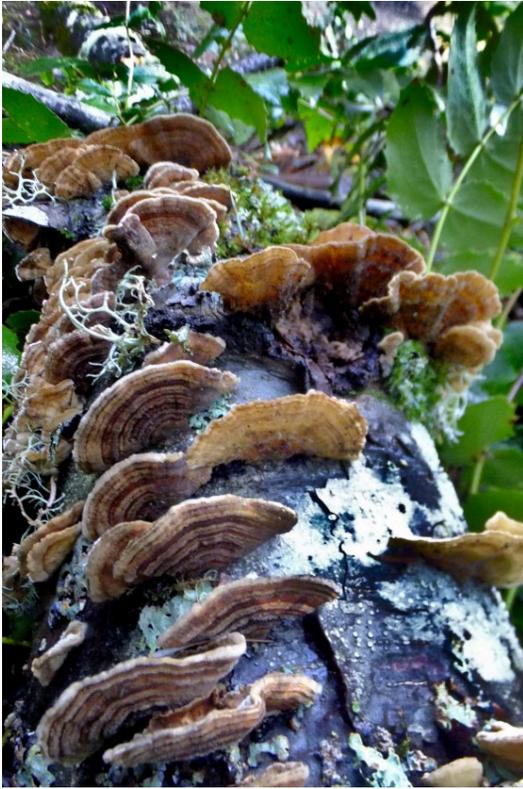
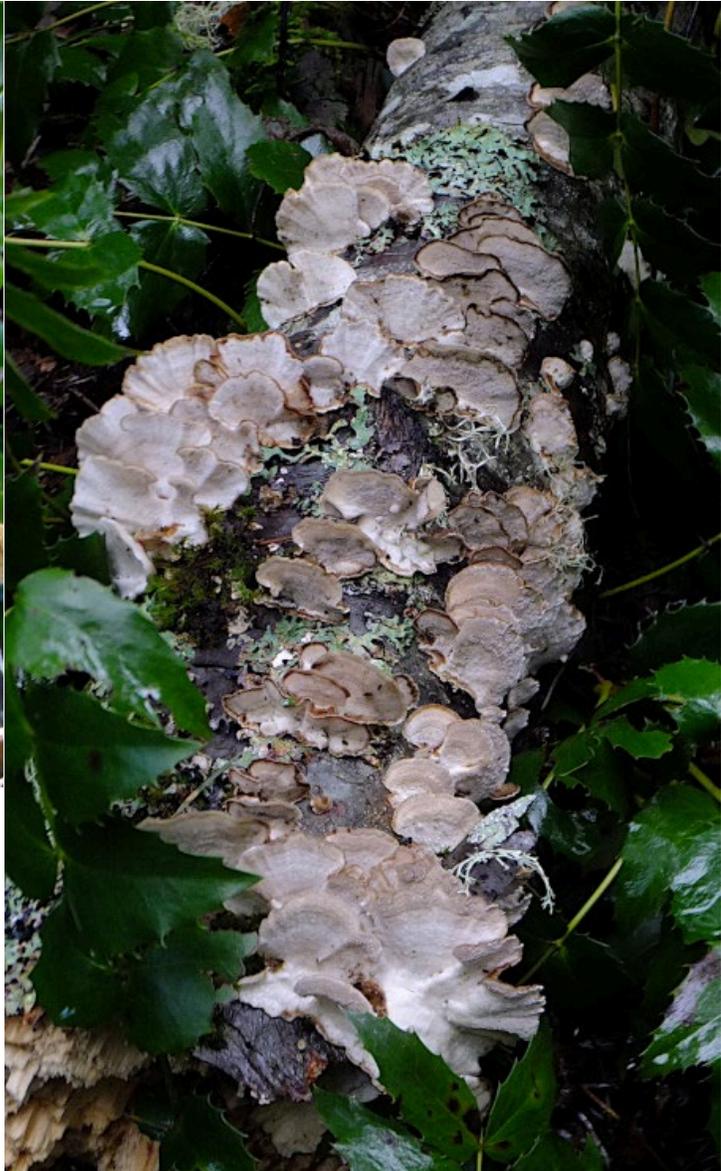
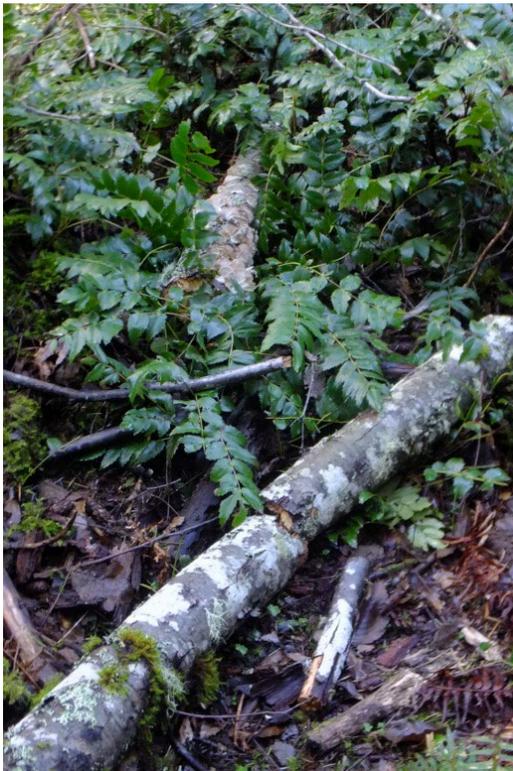
Log (fragment of a white-rot deadfall, probably alder) put aside two or three years ago because it was sporting a good showing of hair ice now showing lots of fruiting fungus.

Likely turkey tail (*Trametes versicolor*). A polypore (above right), fine hairs dense on cap's upper surface, zoned (above left). Possibly a coincidence, but segments of the same log (left) showed no hair ice and are not showing fungus either, only lichen.

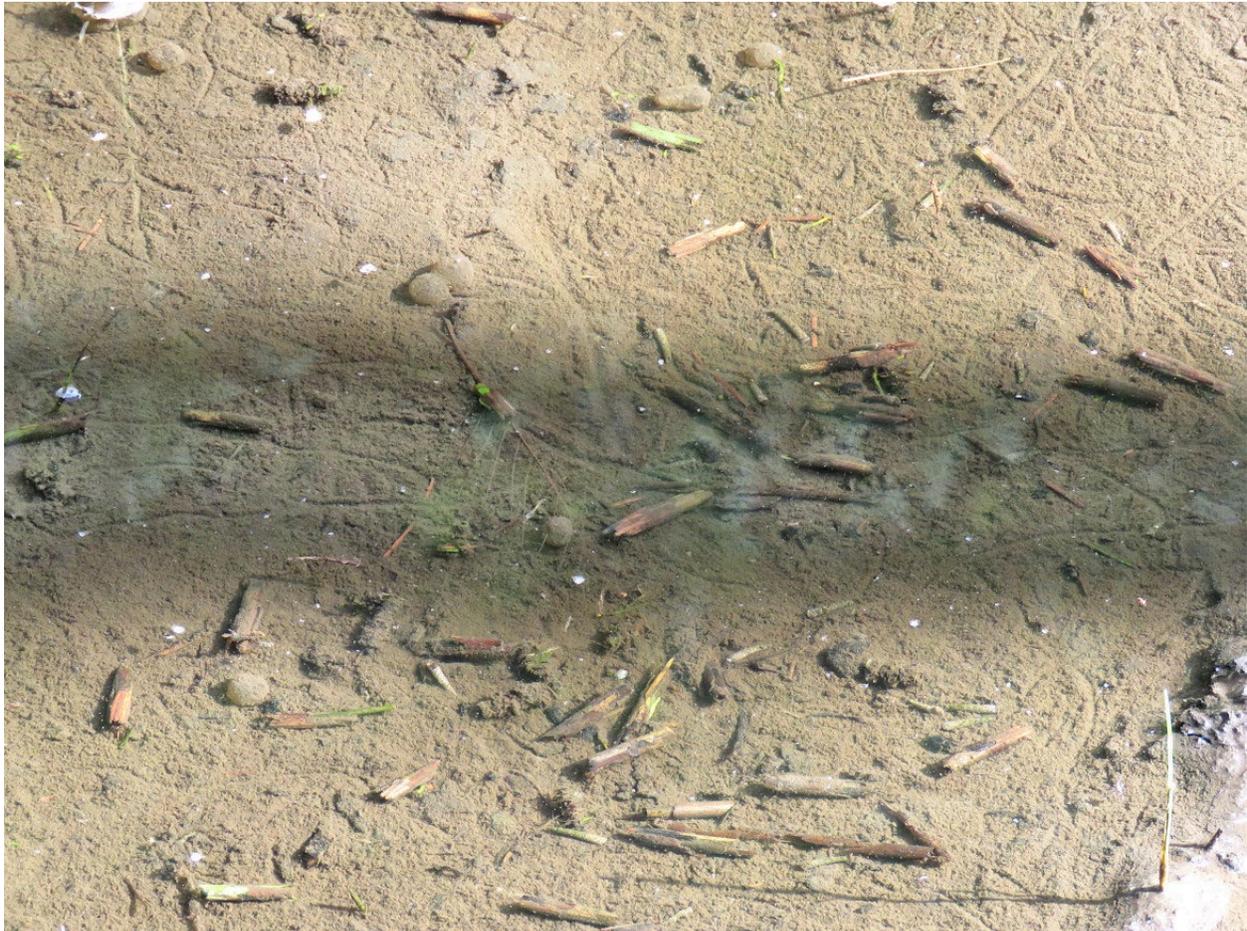
Caddisfly larvae in the Weirpool Creek's flooded parafluvial area. Most of them are hiding in hollow, or hollowed out, rotting reed stems, their presence obvious because of movement and tracks in the mud. Some larvae are using rotten twiggery for their homes; others a collection of muddy detritus. They're bright green, hoping predators will think they're uninteresting shoots. Their presence a good sign; caddisfly grubs require clean, unpolluted water.

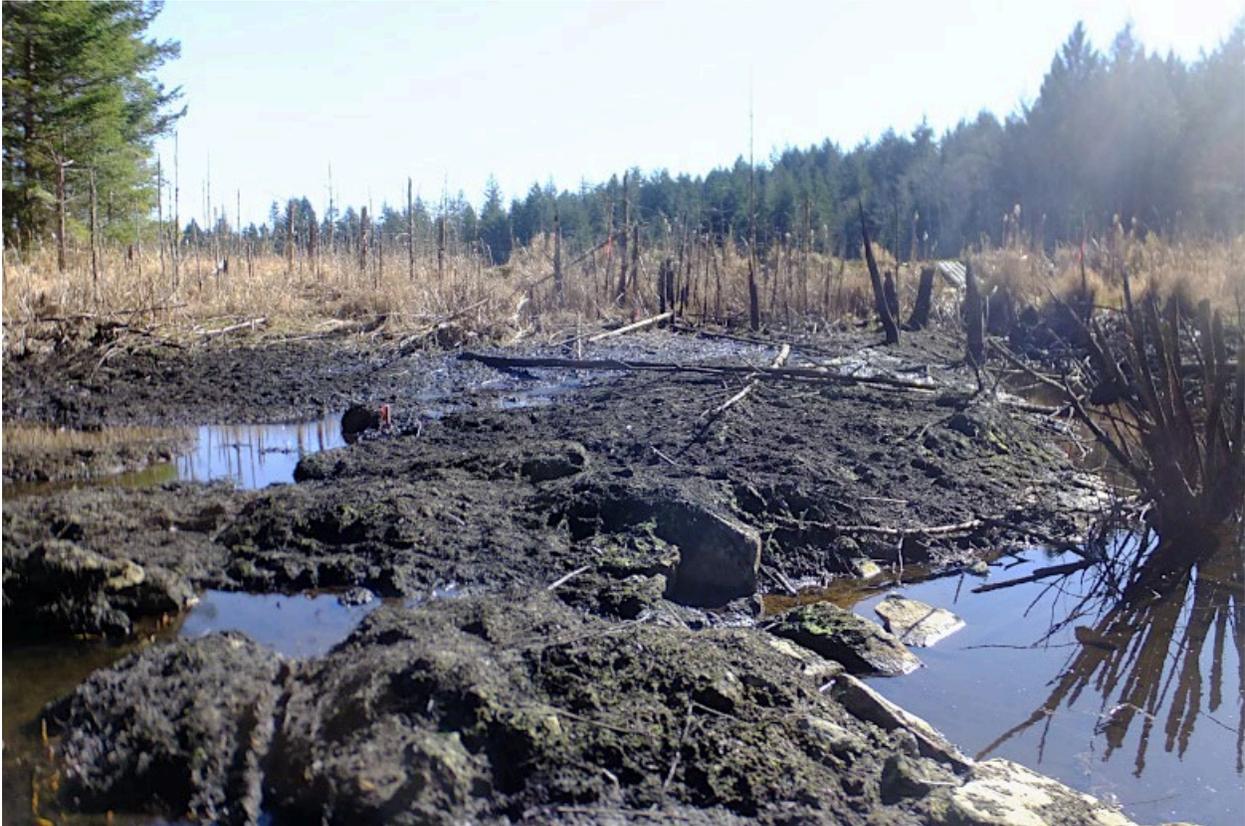
With syphons closed, surprising to see Coats Marsh Creek at the Marsh Trail culvert still flowing strongly. About the same as with the syphons open, but not less. Although the lake is brim full, in the northern half at least, it's not high enough to generate flow across the dam; the water is instead flowing unseen, but noisily, through or beneath the dam. It is flowing through linked pools in the weirpool area to join the creek downstream of the dam. Something for the beaver to repair.
