Gabriola Streamkeepers

Observations of Mallett and Winthuysen Creeks, Gabriola Island, BC, Canada, 2015/16

Nick Doe.

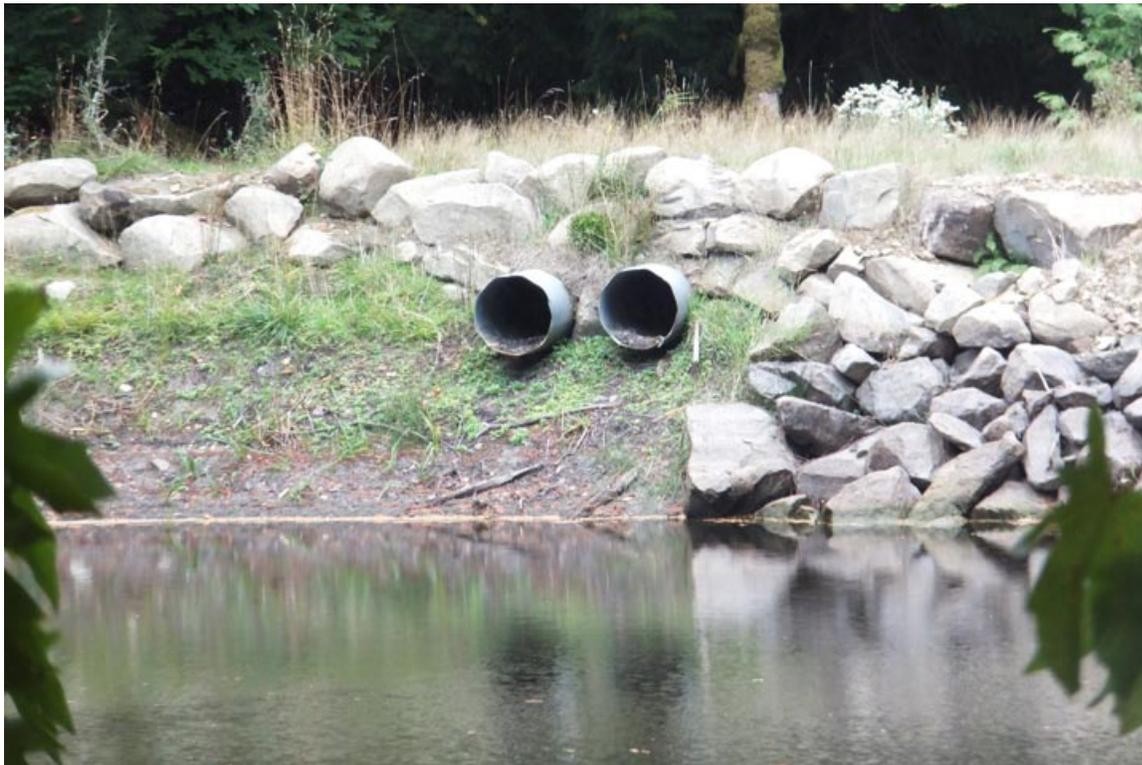
September 18, 2015: Peacocks Lake water level is well below the outlet culvert intake (photo above). 1.27 m below the bottom of the one on the right. Those are 24-inch pipes.

Judging from photographs taken with a telephoto lens including the 610-mm culverts, forty millimetres is very close to the drop in level. It is thus plausible, but not proven, that the lake keeps the creek from drying out completely in summer and thus plays a vital role in providing fish habitat.

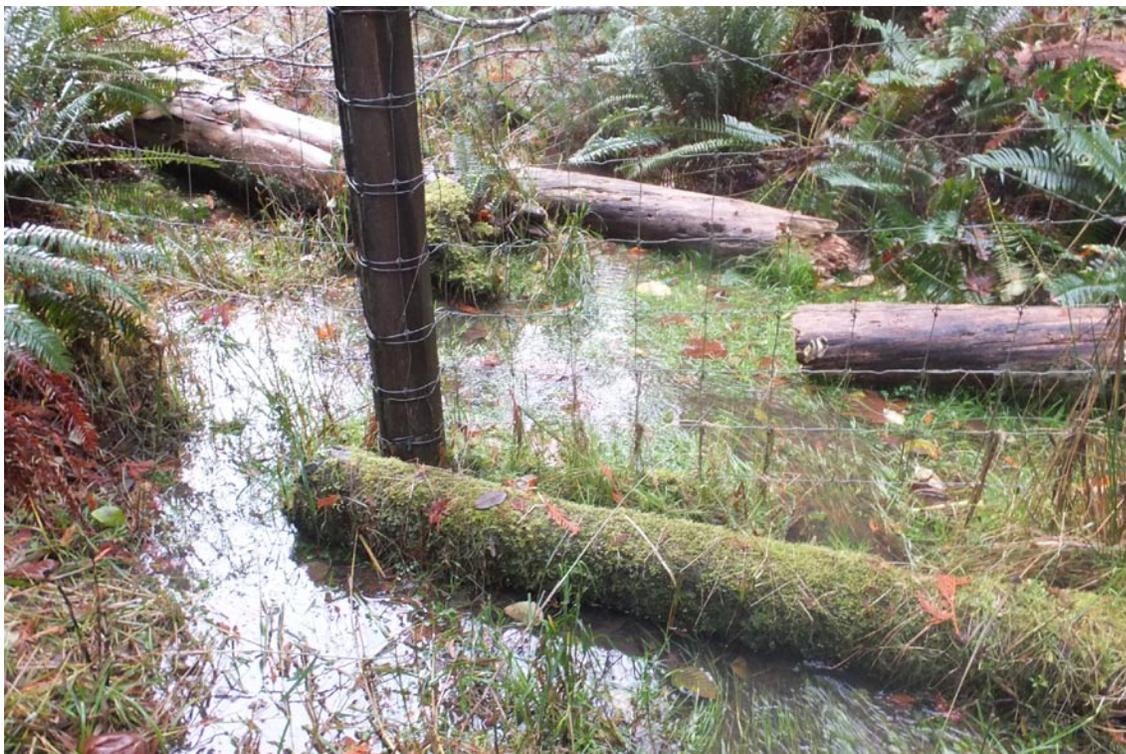
There is now a substantial flow (several litres/sec) from the park into the NE upstream marsh (sedges) side of the lake. This is an intermittent tributary of Mallett Creek that flows from the bridge at River Place. Along its course, it flows through wetland laced with ephemeral runoff rivulets and has a substantial branch about 60m long. The creek, River Place Creek, runs down a fair incline as it approaches the lake, so much so that I would be calling it a “babbling brook” if the tree roots were rock ledges, and the deadfalls, boulders. Because of this seasonal expansion of the watershed, the flow at River Place is significantly less than the total inflow to the lake. Mallett Creek proper, shown above, runs from the SE through a gully to the nose of the lake.

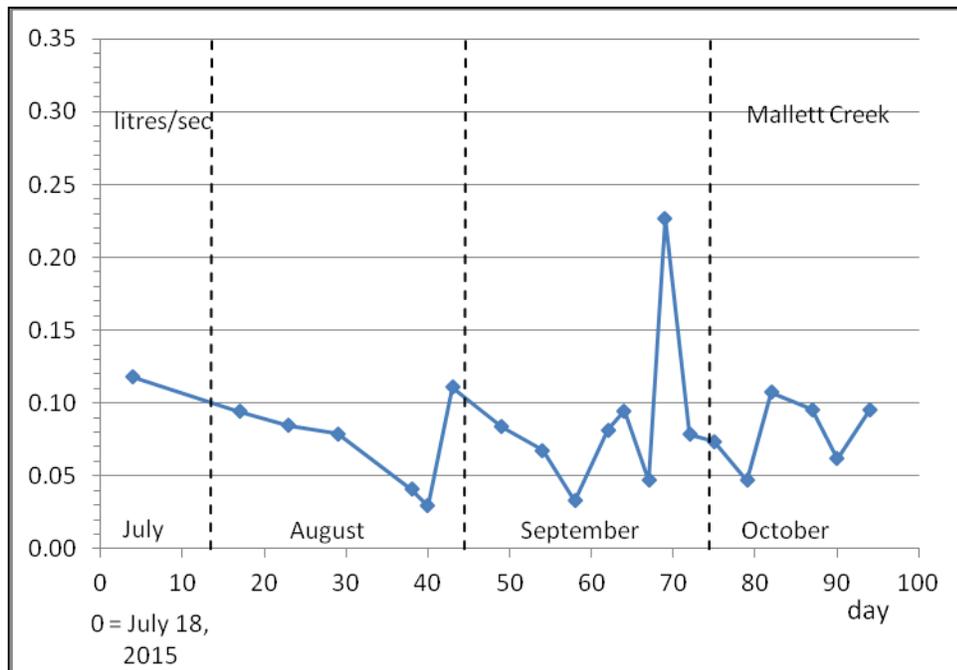
Precipitation appears to affect the flow rate almost instantaneously, but there is a steady, but in summer always declining, small flow not related directly to precipitation. There is at the same time, absolutely no flowing water in Winthuysen Creek.

Possibly the “groundwater seepage” is actually leakage through the dam wall? The source is without doubt somewhere upstream of the half-way culvert.

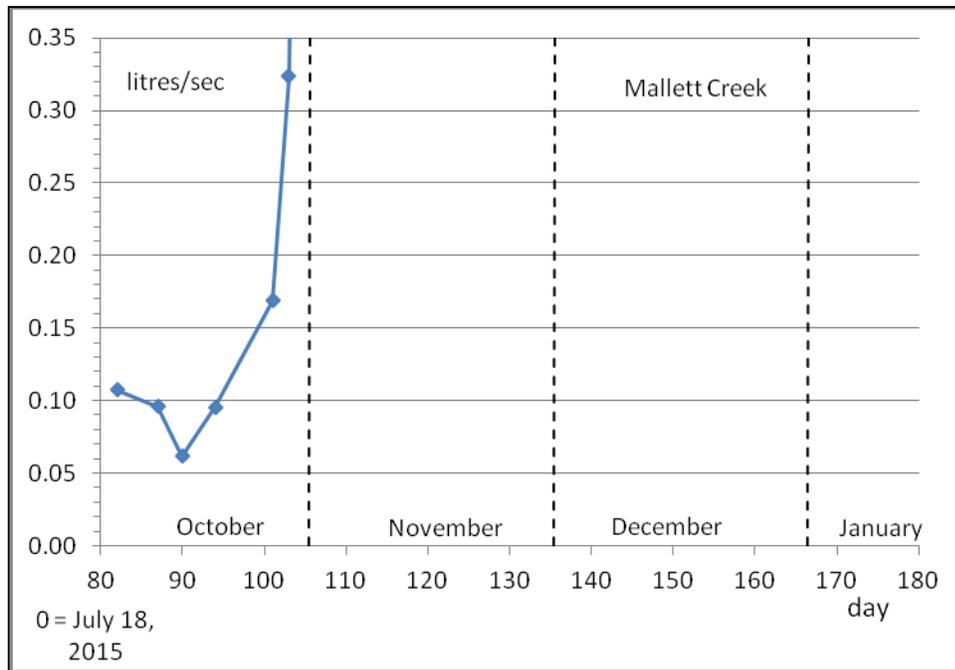
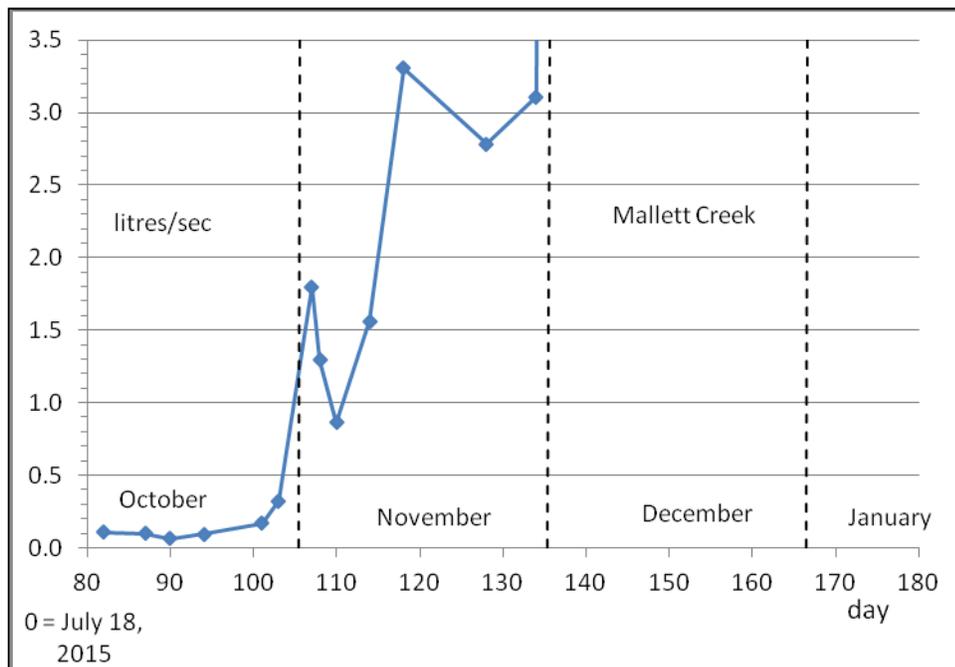
Note change in vertical scale

Flow peaks in direct response to rain, declines almost immediately after it stops. Evidence is that at this time of year, with no flow from the dam outlets, most of this water is collected rainfall from the valley below the dam.

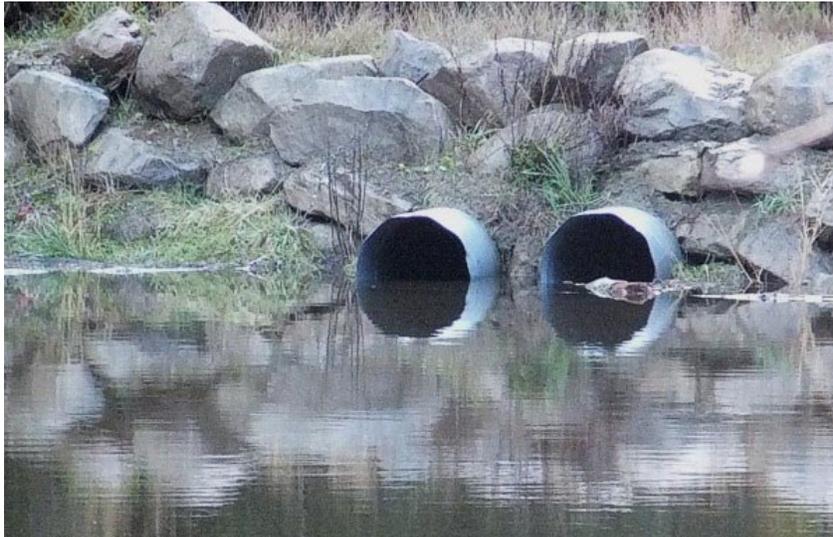
Peacocks Lake is now full up to the two 610-mm outlet pipes. Depth, judged from Cox Park is 260 mm, so flow in each pipe is in the 70–125 L/s range each (no velocity measurement), which is more than the culvert flow, so something is not quite right with these estimates and measurements.

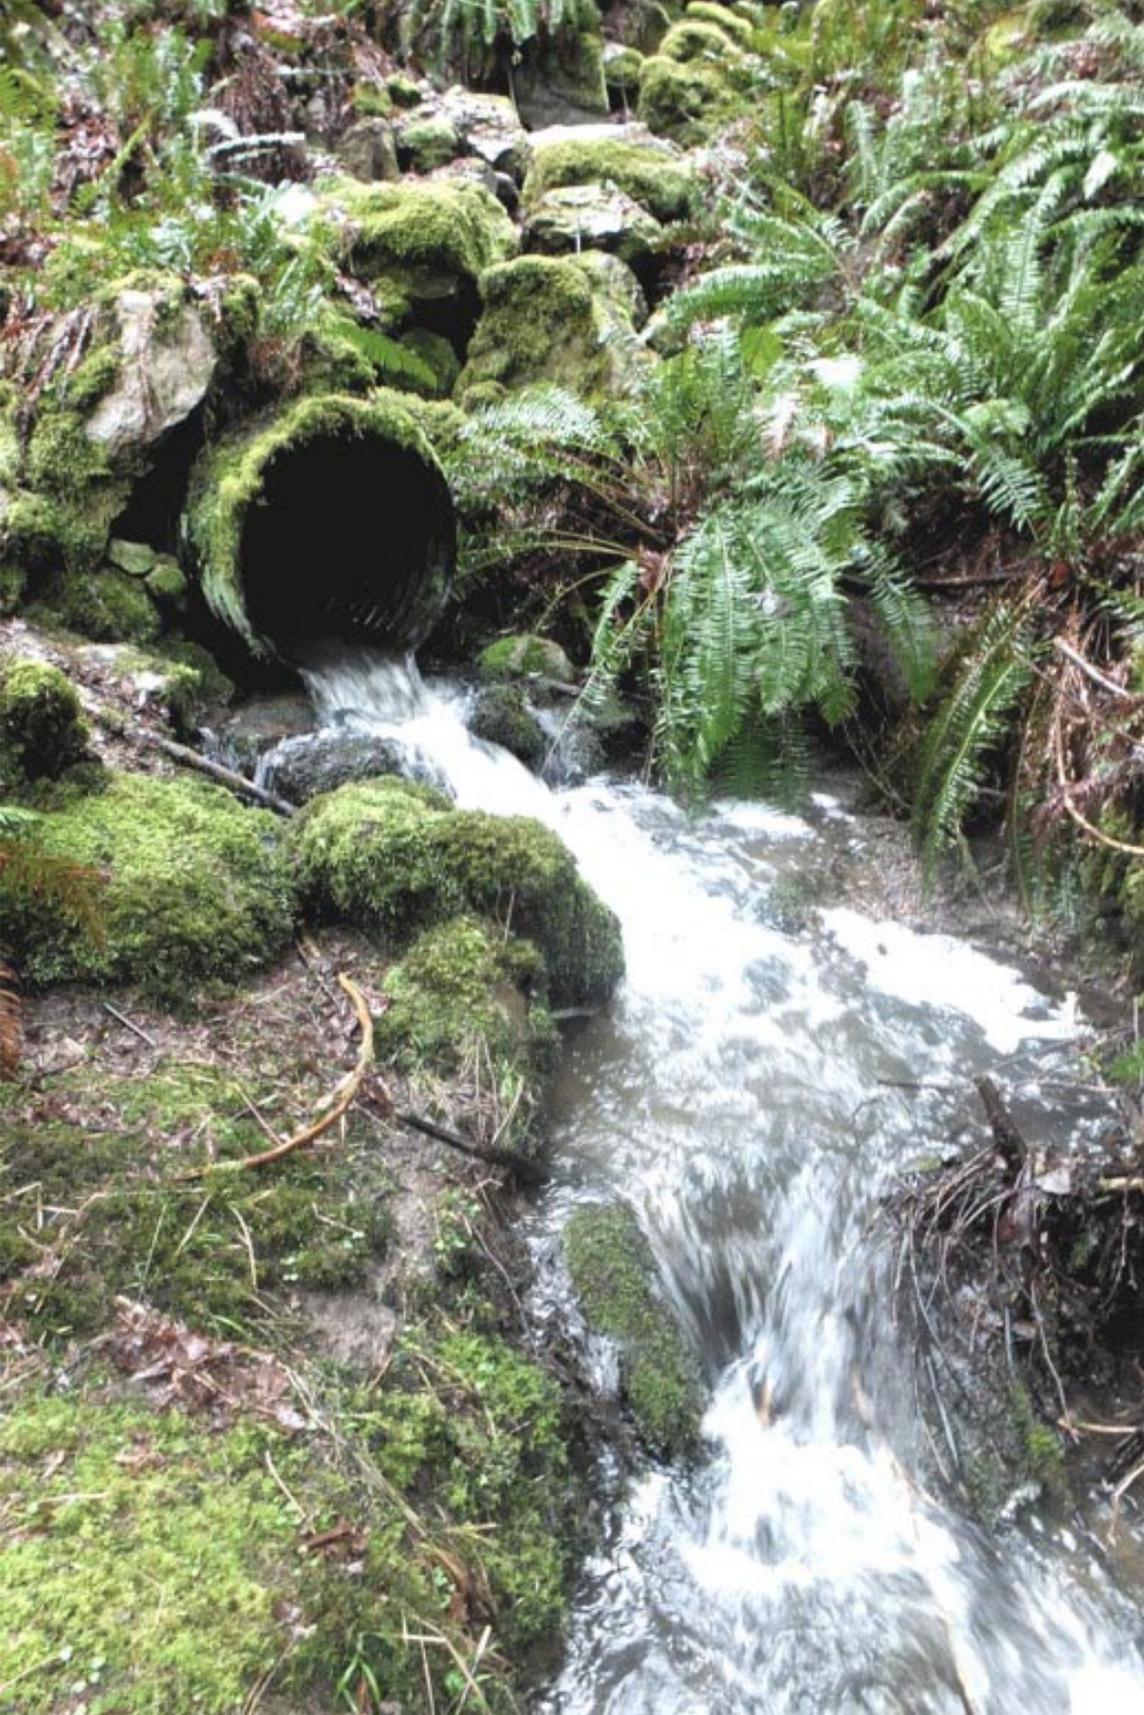
Feb. 5 (202): Mallett: 34.5 L/s, rain calib. = 69.0 mm at the creek.
water depth = 85 mm, water vel = 1.33 m/s (float). Photo.

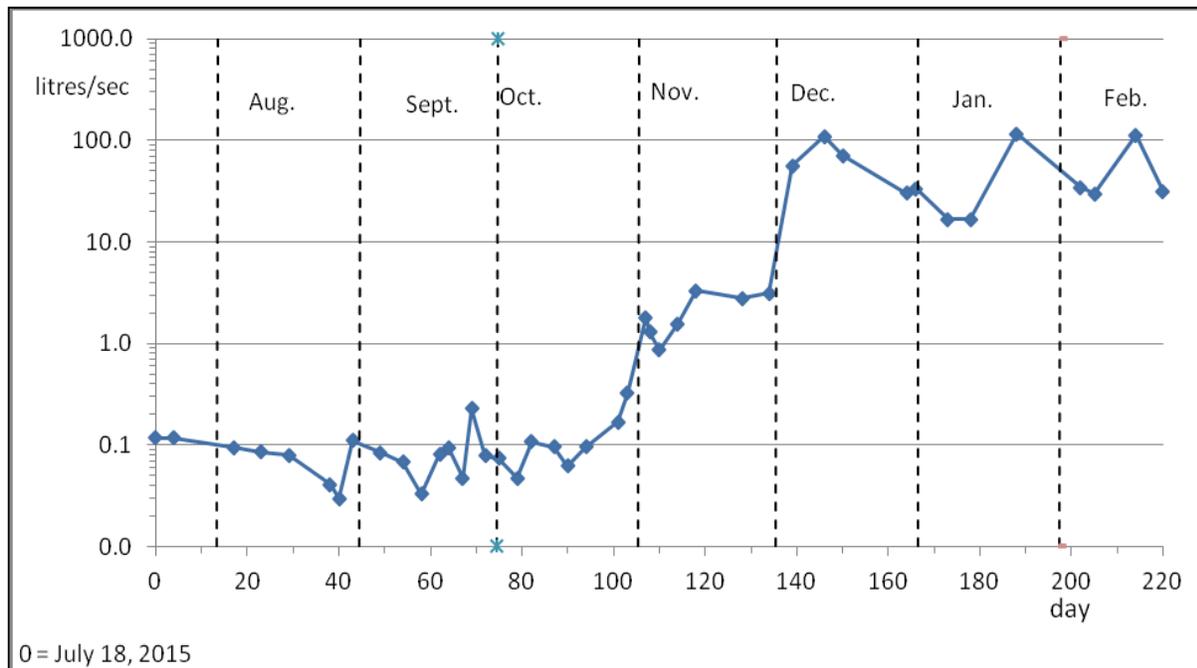
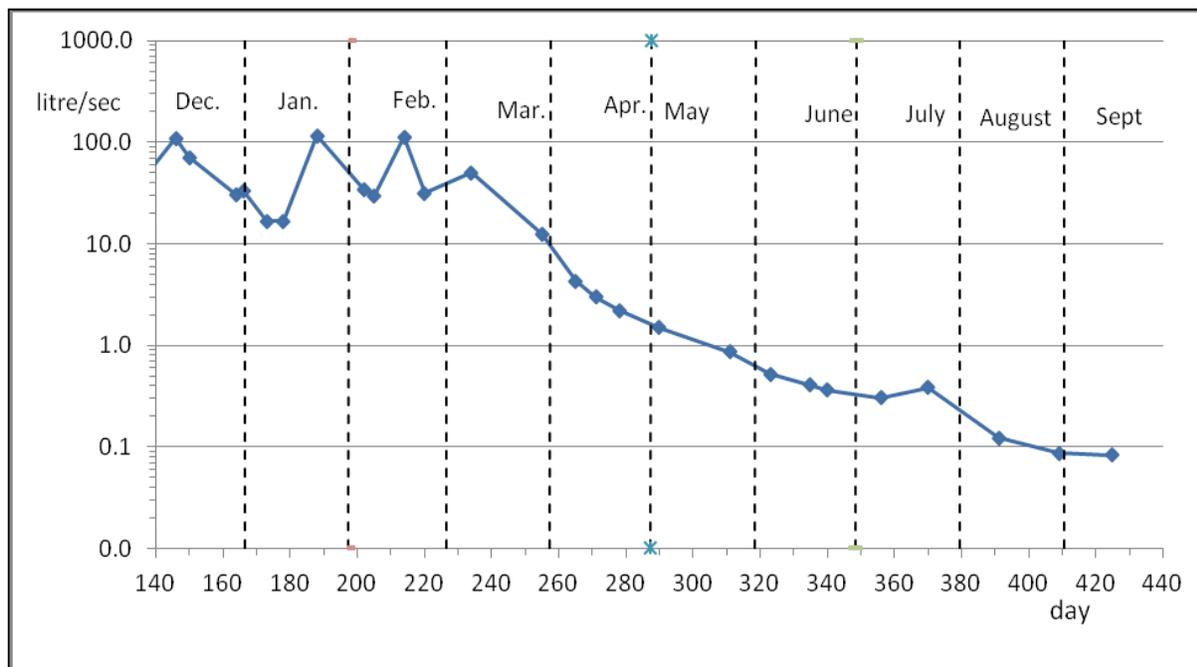
The flow in Mallett Creek varies by over three orders of magnitude from:

- the summer dry season (<1 L/s);
- to the fall, when rainfall in the ravine below the dam increases the flow (<10 L/s) but there is no flow from Peacocks Lake;
- to the time in the winter when Peacocks Lake has been recharged and water is flowing through the two outlet pipes (<100 L/s) from the upper reaches of the creek.
